Conservation of the *Abi* at Urkesh: the years 2013-2017

Stefania Ermidoro, Yasmine Mahmoud

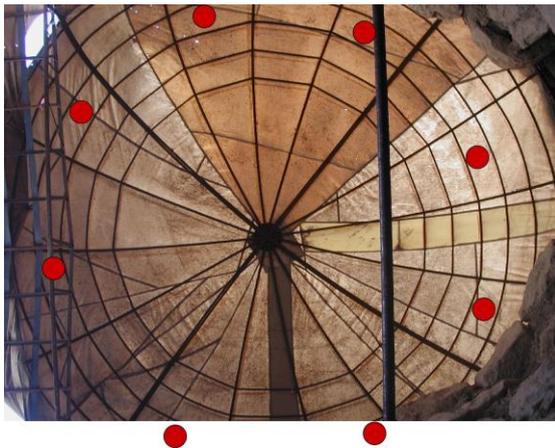
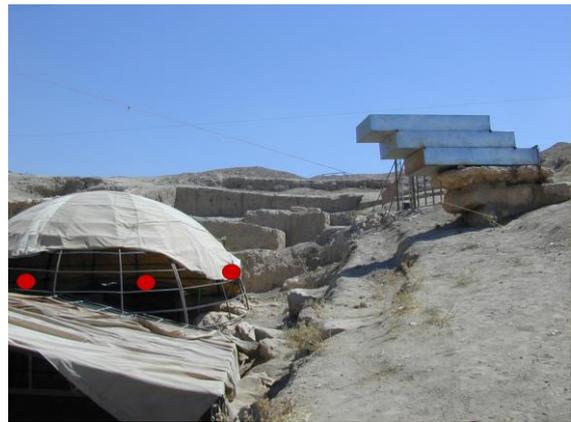
Fig. 1: Photos with the indication of the openings to be created in the new metal dome for aeration and light inside the *abi*

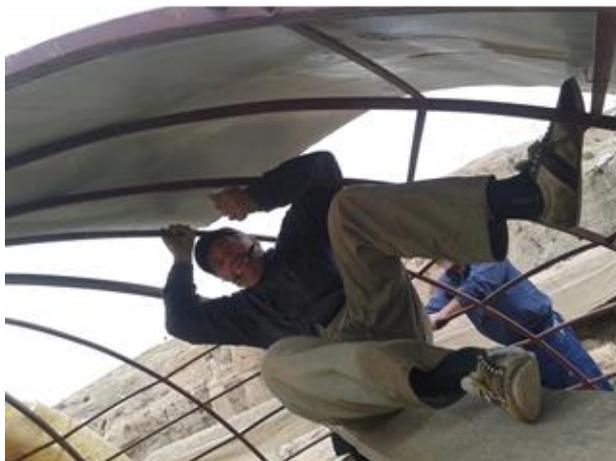
Fig. 2: First day of work on the *abi* dome

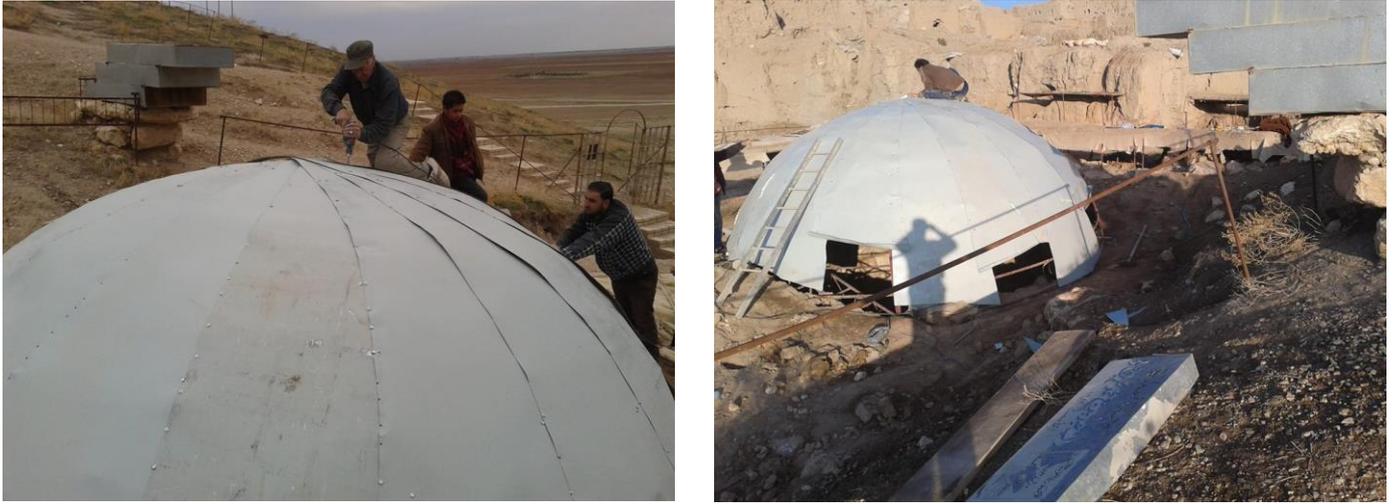
Fig. 3: Sabah Khasseem at work (left) and detail of the openings at the base of the new *abi* dome

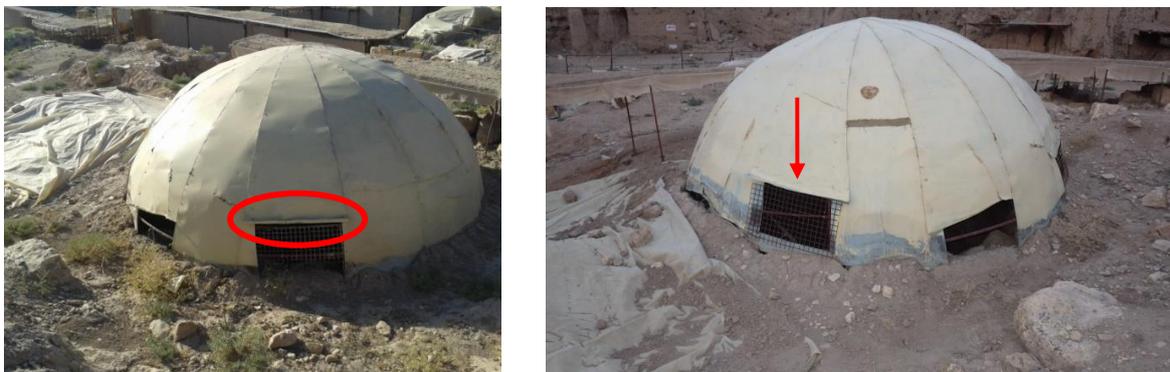
The ventilation openings for which we had asked in the new structure were working well, preventing overheating and allowing some light inside the *abi*. Three small openings have been left at the bottom of the dome, at its southern and south-western sides: these are rectangular in shape, and covered by a metal net to prevent animals and any other external elements from entering the structure.

Each one of these openings has a thin metal sheet on its top, which is tilted upwards and slightly longer than the holes themselves: this has been done for a specific reason. As can be seen in the photo, these unobtrusive installations create a kind of small drains, so that rain is channelled and seeps out, preventing the water from leaking into the *abi* (Fig. 4).

Fig. 4: Showing the openings and the drains above the openings

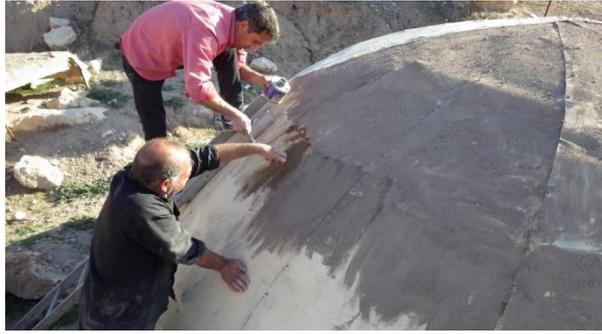
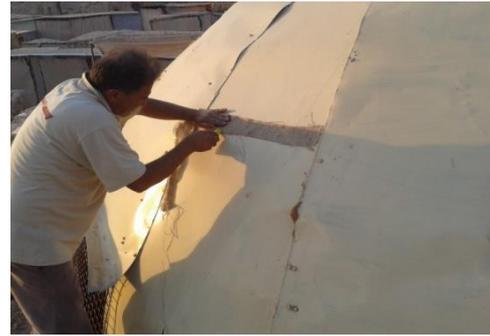
The dome was therefore completely covered, but using the two methods – each for one half of the structure: half was covered with dirt (Fig. 5a), the other half with burlap (fig. 5b). Initially, both methods seemed to give the dome a very natural look and to be unobtrusive with regard to the surroundings (Fig. 6). However, we had to observe how the two systems reacted in a longer period: thus, we asked our workmen at the site to look carefully at the dome in the following months in order to check how the covering system reacted to the atmospheric agents and in general to the passing of time.

Fig. 5: Covering half the dome with dirt (5a, on the left) and the experiment with burlap (5b, on the right)

We realized that neither of the two previously experimented system with the *abi* dome was efficient: the two halves, covered with glue and dirt or with glue and fabric, did not resist sufficiently the local weather conditions. The burlap was ripped by wind and deteriorated because of the rain and snow, and for the same reason also the dirt layer was not uniform, but patchy. The overall impression was that of a neglected situation which we obviously wanted to avoid. Therefore, we decided firstly to clean the entire dome surface from any leftover dirt or glue, and then to paint it with a color close in shade to the surrounding. This paint coat will also prevent rust form forming.

After a period of observation, we determined to use the burlap for the entire dome – substituting the half covered with dust whenever the meteorological conditions would have allowed it.

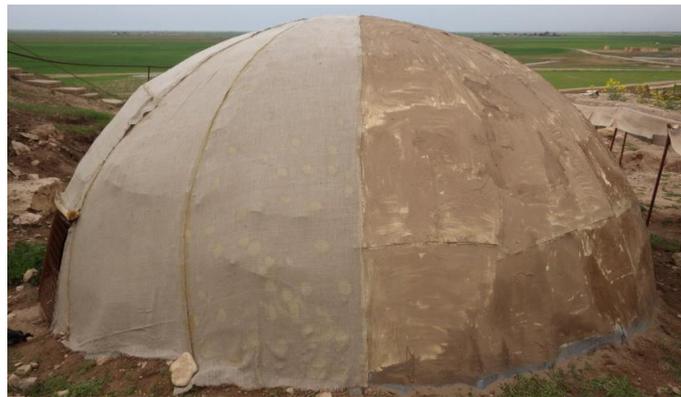
Fig. 6: The *abi* in June 2014

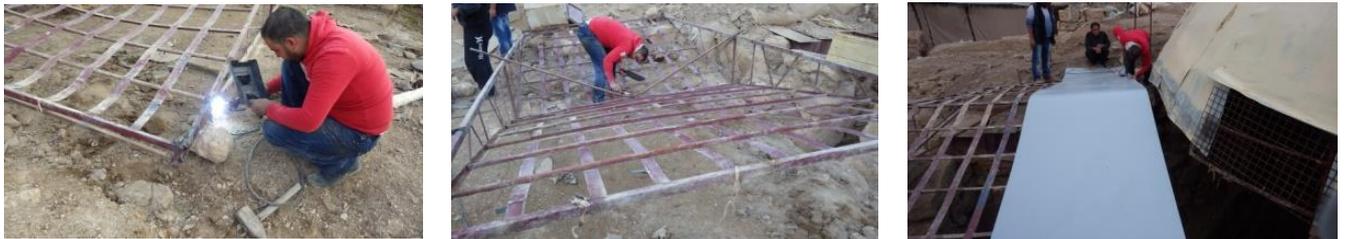
During the fall 2013 and winter 2014, this particular system suffered a great deal and was badly damaged due to weather conditions (especially snow), plus it was dented in several places and needed maintenance to ensure an overall full protection. The workers had taken some emergency measures to stop the water from seeping in, by placing pieces of nylon in the brakeage locations. However, a serious structural intervention was needed.

Fig 7: Different stages of work on the entrance

At first, the workers removed the whole metal structure, in order to evaluate its condition and fix its damaged junctures. The parts which were dented were straightened using a hammer, and a supporting bar was placed at the central top point of the top and extended to the two bases, welded to provide extra stability and support (Fig. 7).

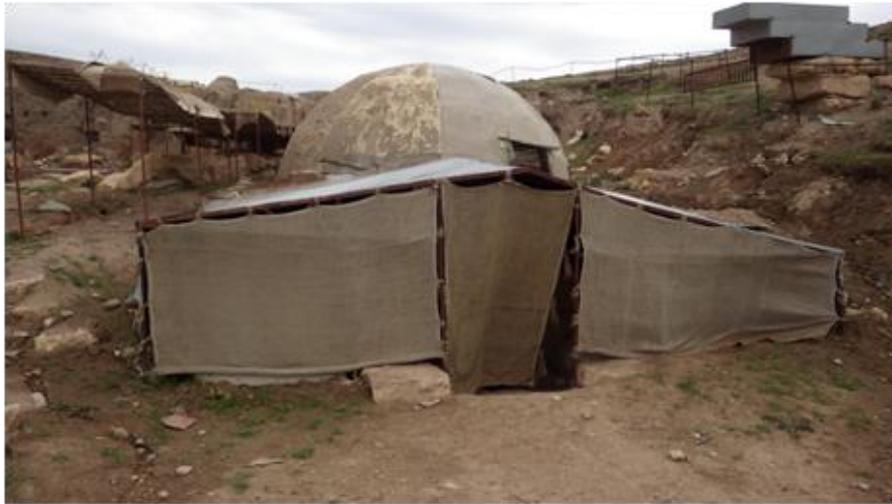
Fig. 8: The *abi* in December 2014

Finally, the curtains used on the sides of the entrance and on its façade and doorway were replaced with new ones (Fig. 8).

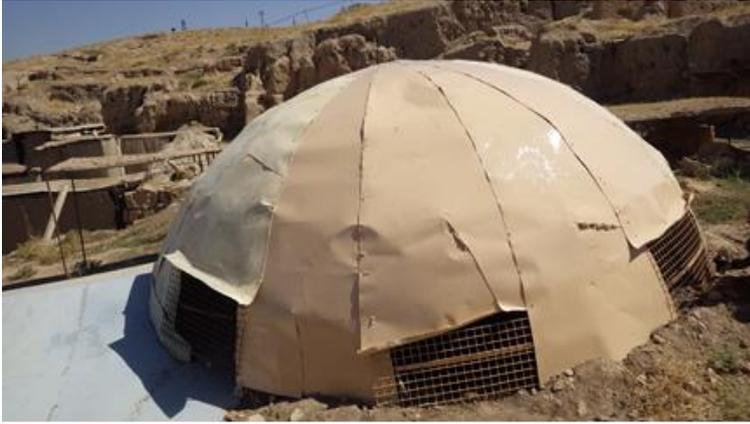
Fig. 9: Painting the dome in 2017

So far, this solution has proved to be efficient and has satisfactorily endured the summer and fall months, and after monitoring the dome of the *Abi* for two winter seasons in 2017 and 2018, we can safely say that the painting method has been very efficient. No repainting has been needed up to this point, which proves that the approach we adopted is indeed the simplest and most cost-effective in protecting the dome of the *Abi*, according to our local staff and the periodic monitoring photos that we receive.

Our workmen from Mozan, thus, covered the entire surface of the *abi* dome with paint. The result, as shown in the photos on the left taken while the painting was still in progress (Fig. 9), is unobtrusive and
