## The maintenance works in the area J1

Amer Ahmed

Date : 11 / 9 / 2019

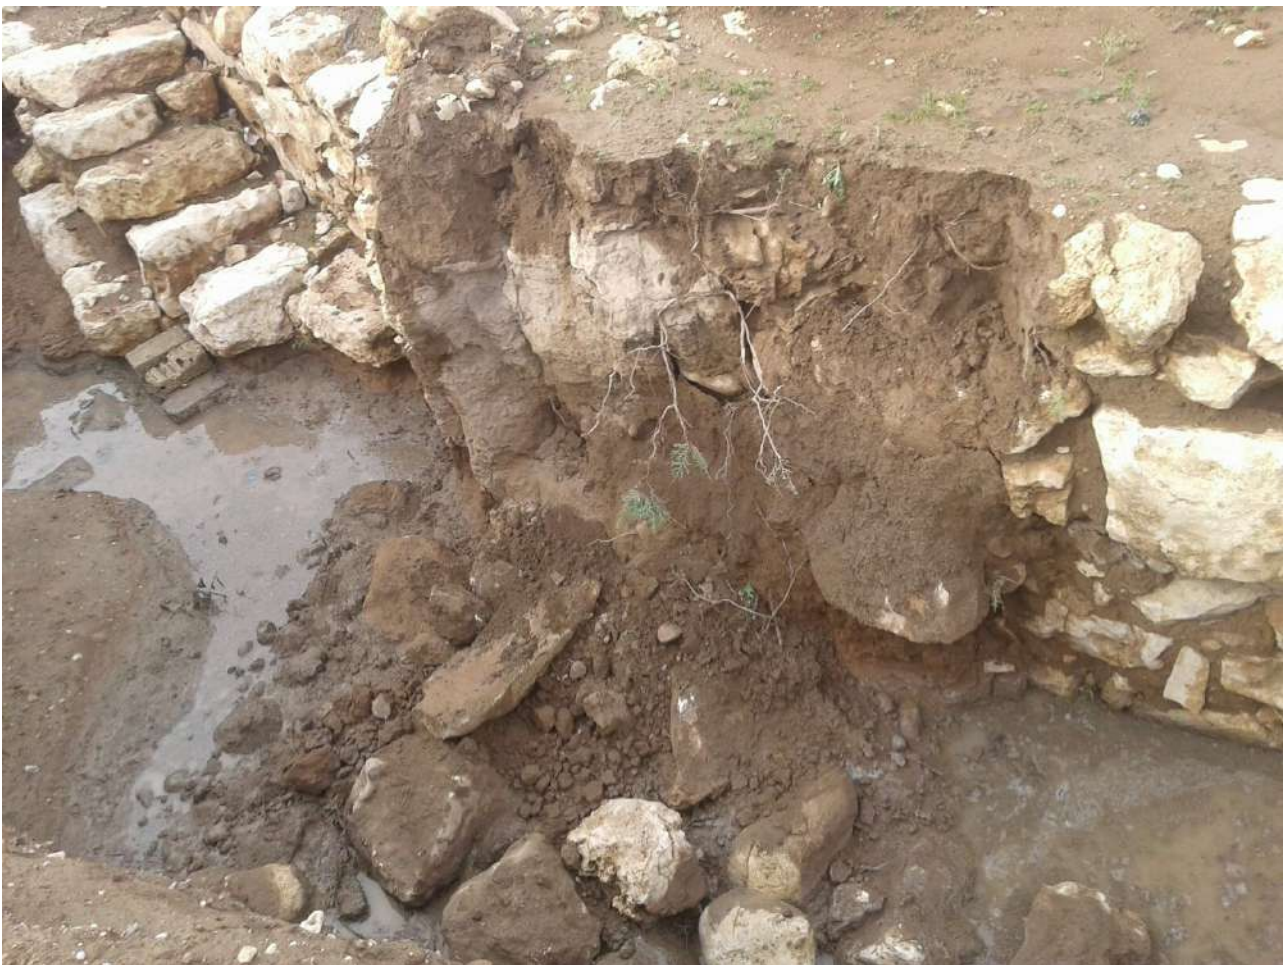
Due to the extraordinary weather conditions which prevailed the province of Hasaka last winter, Tell Mozan site was subjected to some damages, where the buttress which used to support the wall of the temple in the unit J5 ( **Fig. 1** ) and the soil of the unit J1 have crumbled in the area J ( **Fig.2** ) . So we immediately alerted the team of the Mission in order to find an urgent solution. After careful analysis and consulting, we have identified a suitable strategy to secure the area and the ancient wall structures . But we couldn't intervene immediately to repair the damages, because of the heavy rain through the spring, so we had to wait until the end of May where the weather became appropriate for the work .

Fig.1 . The crumbled buttress in the unit J5

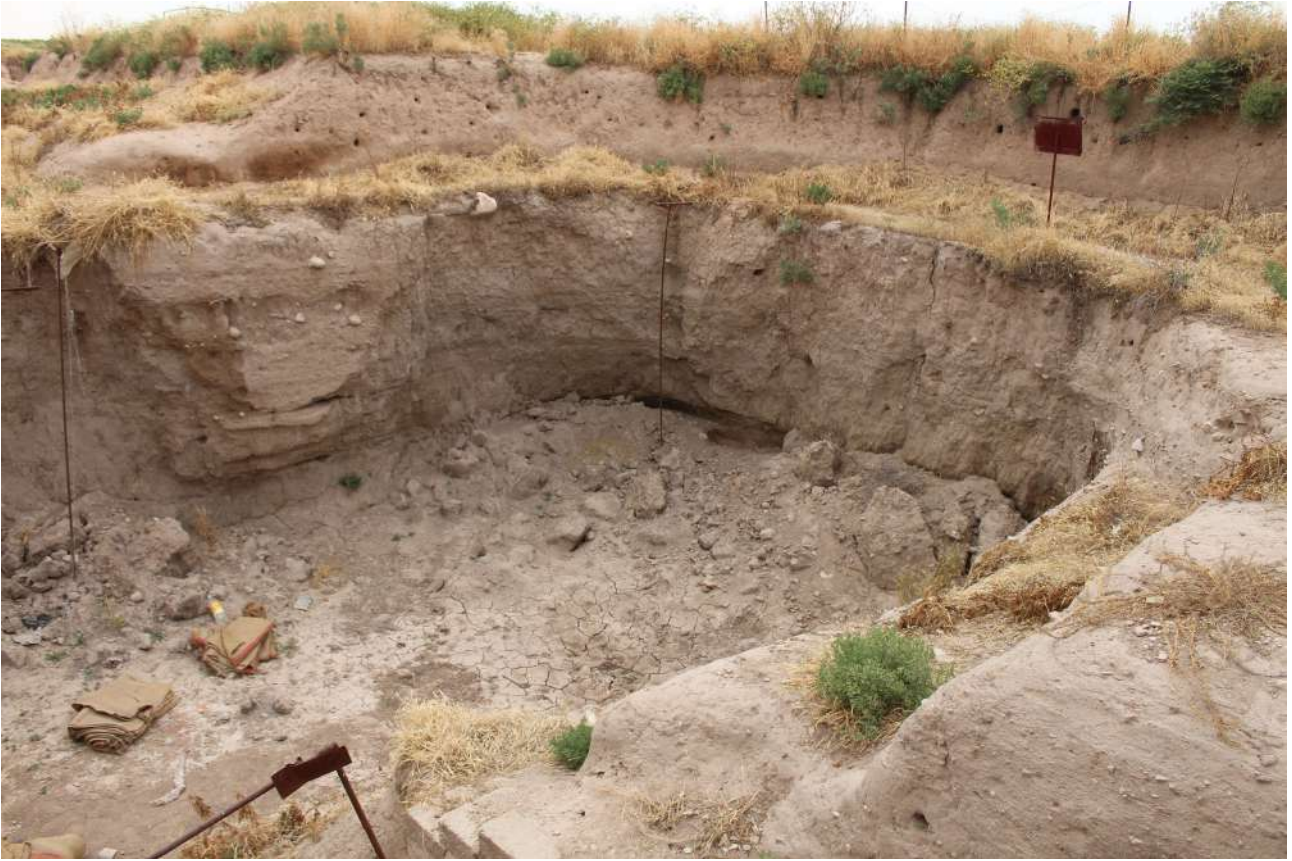
Fig.2 . The unit J1 before the work

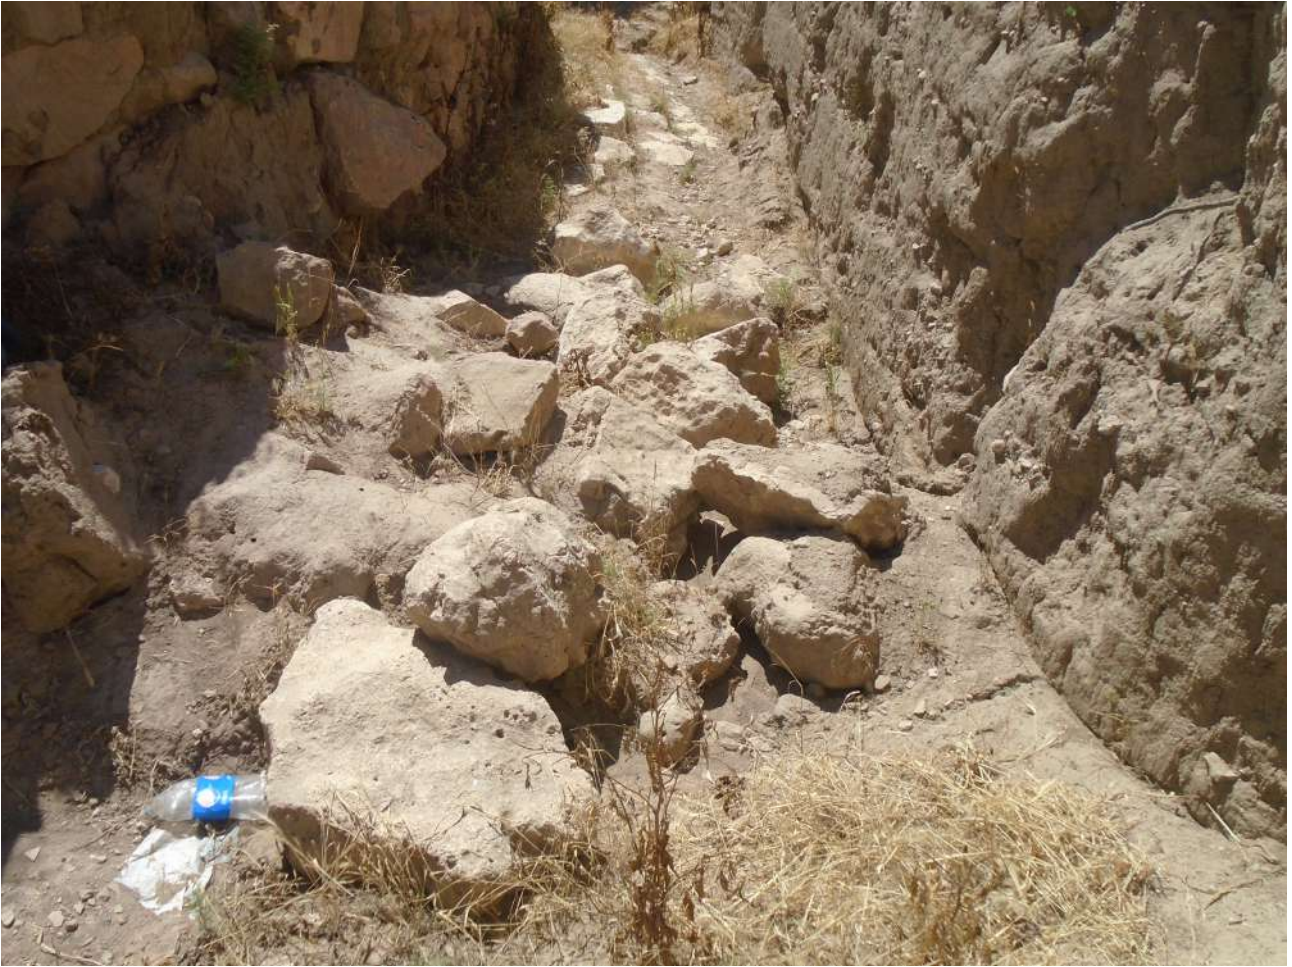
We started in the unit J5 where the collapsed buttress, which has been supporting the fence of the temple in the ancient times . The huge stones were scattered on the ground with accumulated soil on them ( **Fig.3** ). Because of the lack of enough experience to restore this buttress as it was, I surly believed that this process needs to be supervised by the Mission itself.

Fig.3 . The accumulated soil and scattered stones - the unit J5

So we suggested the repositioning of stones somehow, as a support to protect the wall of the temple in the unit J5, as well as keeping them until the return of the Mission .

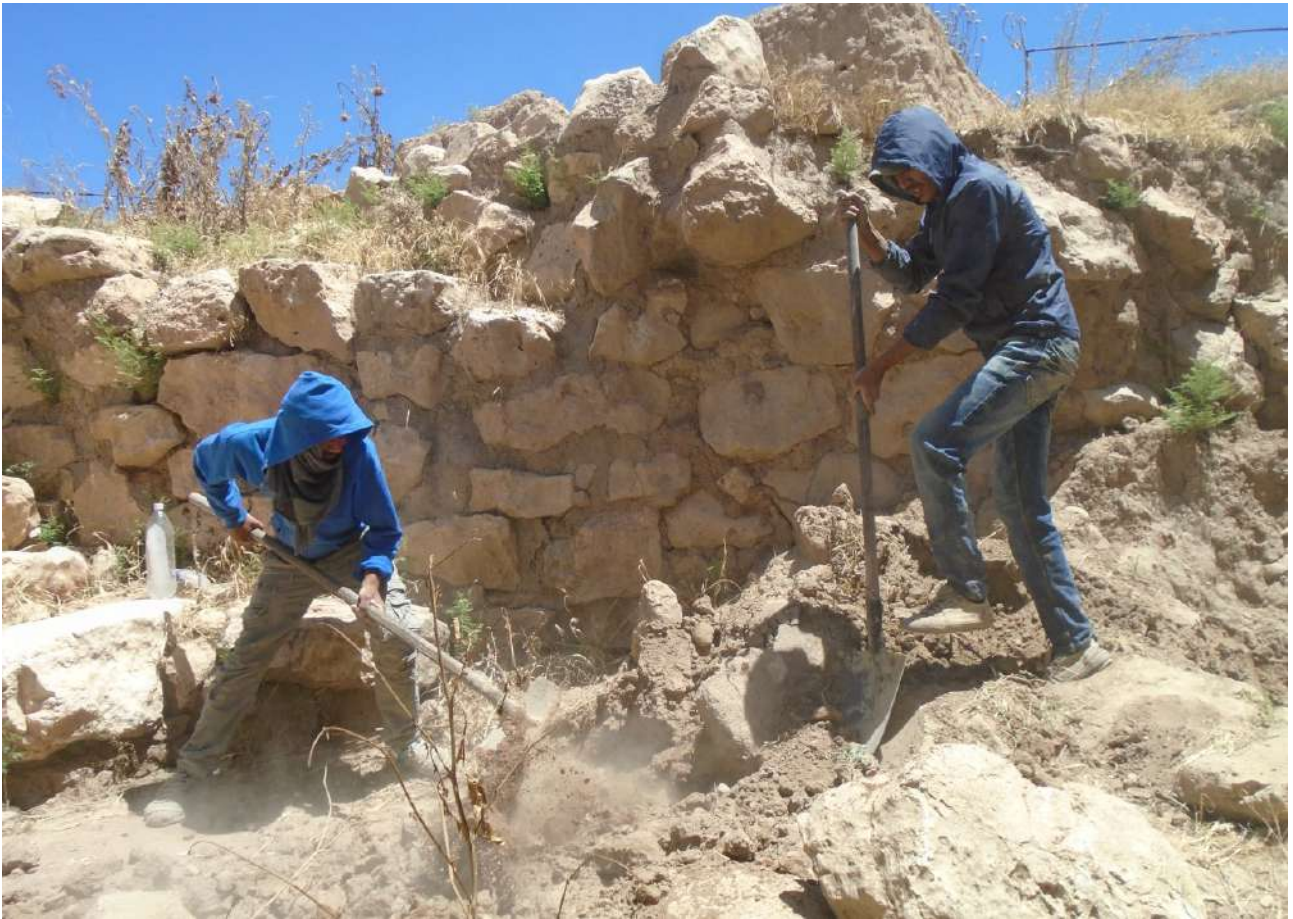
Fig.4 . Removing the soil - the unit J5

We started removing the soil which was accumulated on the stones (**Fig .4**), then sorting them to put the biggest in the bottom to form a base, we were very careful to not disturb the soil that remained from the original buttress and still sticking on the wall of the temple ( **Fig.5** ), the soil was reddish and free of straw and shards, but contained few small stones,“I think it is none sifted soil ” .

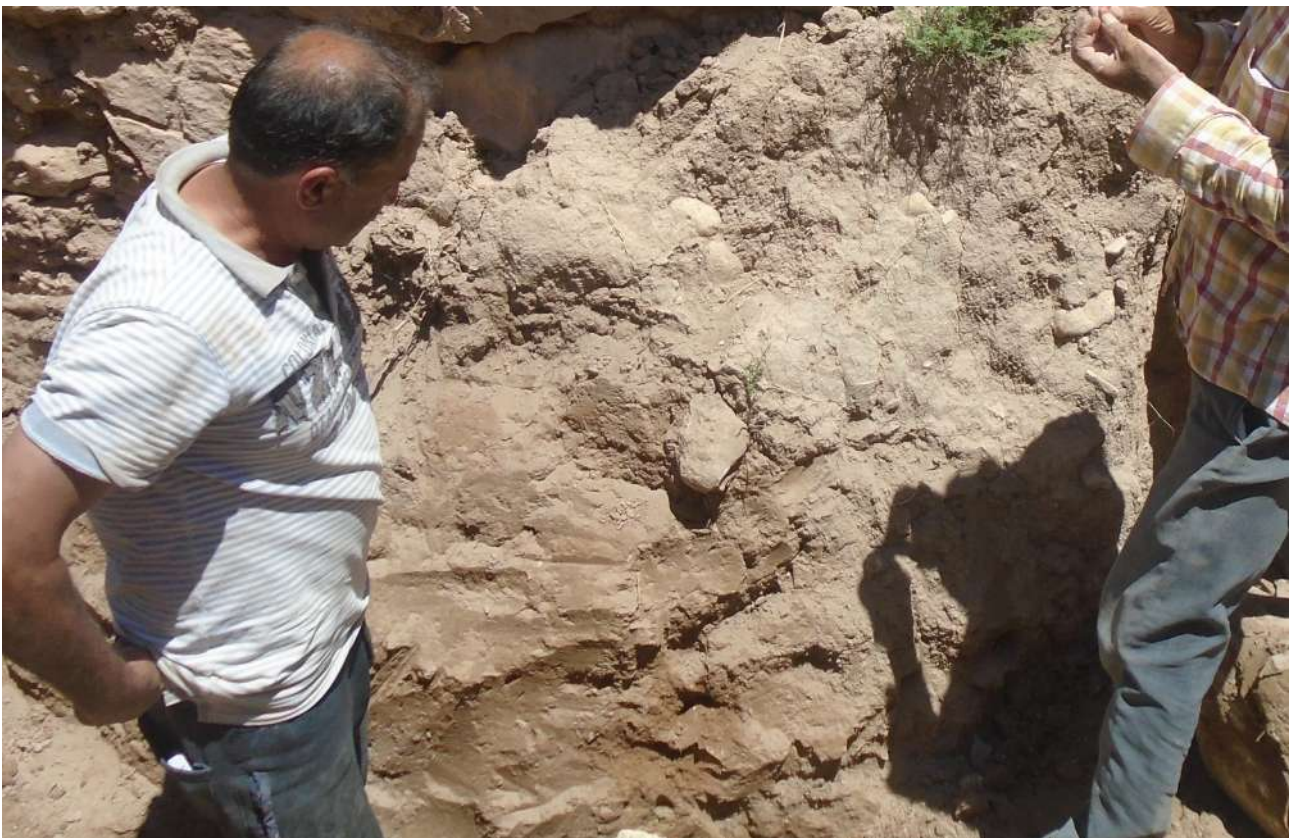
Fig.5 . The soil which remained and still sticking on the Temple's wall - the unit J5

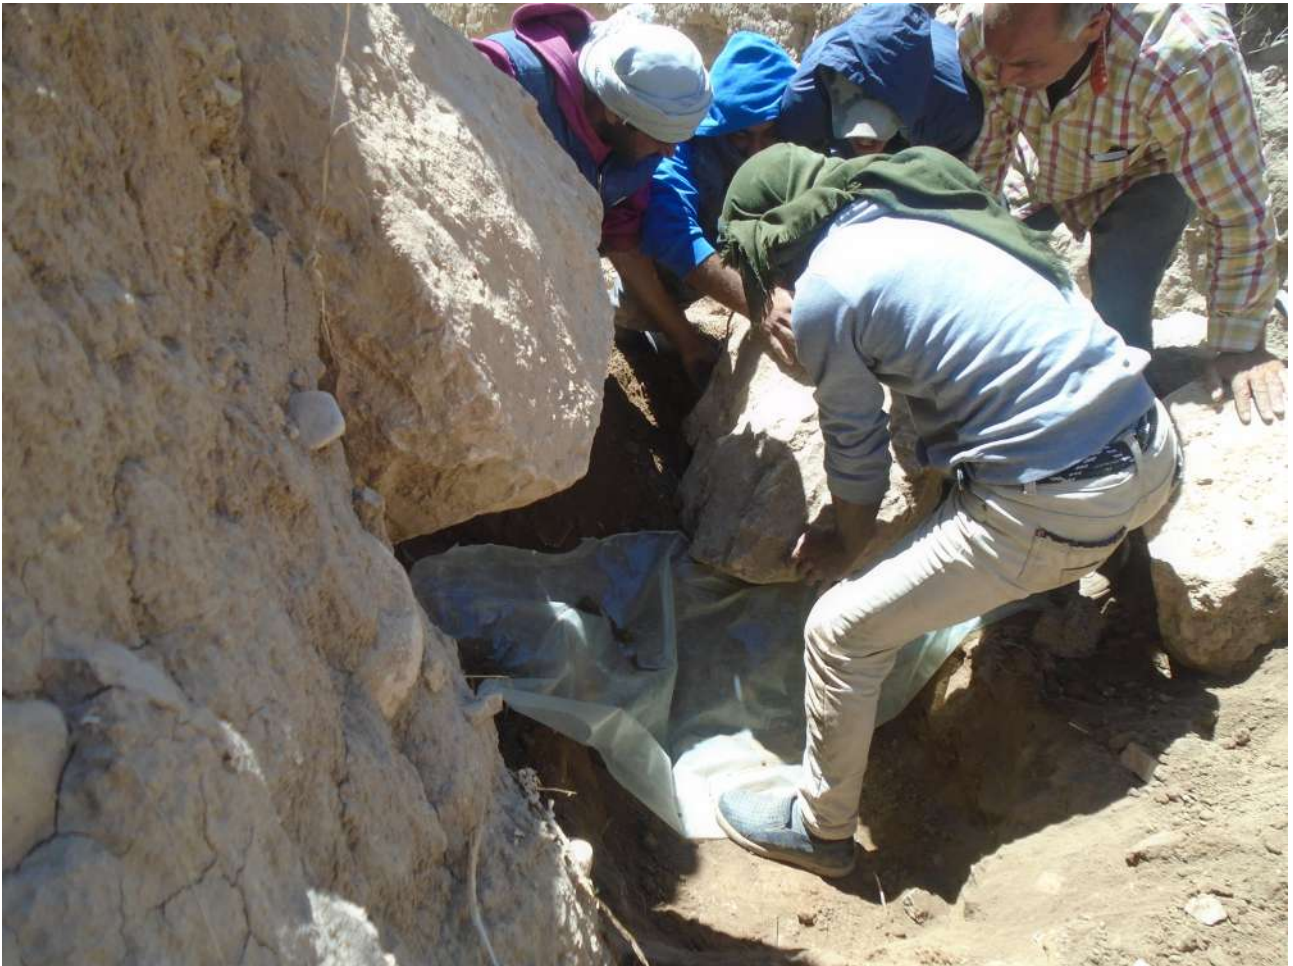
Fig.6 . Using plastic ( Nylon ) under the stones - the unit J5

After cleaning the unit from the soil and reaching to the excavated level, we have put a plastic ( Nylon ) ( **Fig.6** ), then the biggest stones as base .

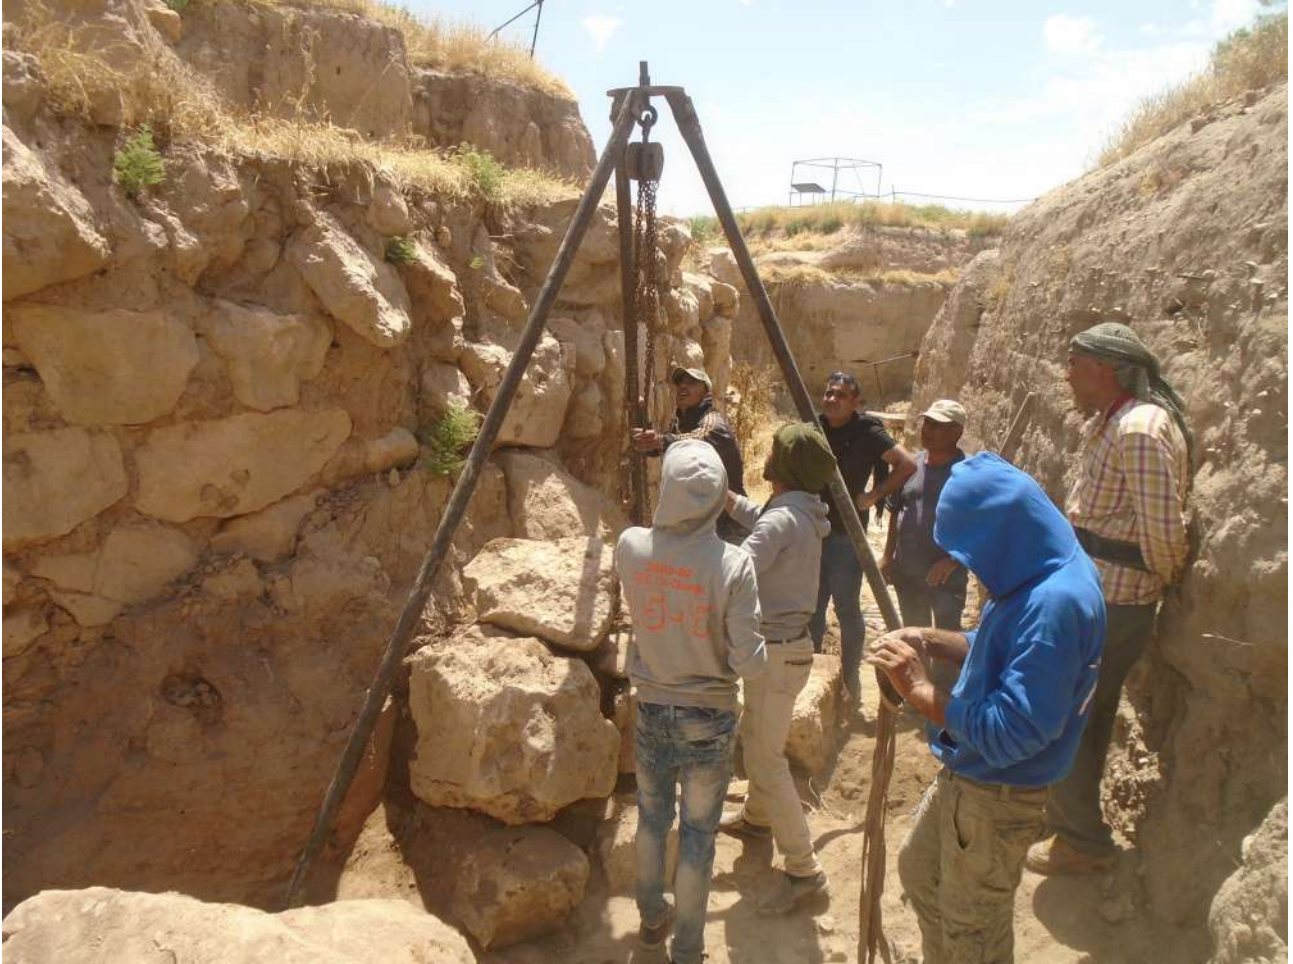
Fig.7 . Instrument of al-Wensh - the unit J5

The work continued in the unit J5 but because of the difficulty of lifting stones we have relied on an instrument which is called al-Wensh in local language to lift the stones ( **Fig.7** ), however, we were having difficulty working because of the large stones .

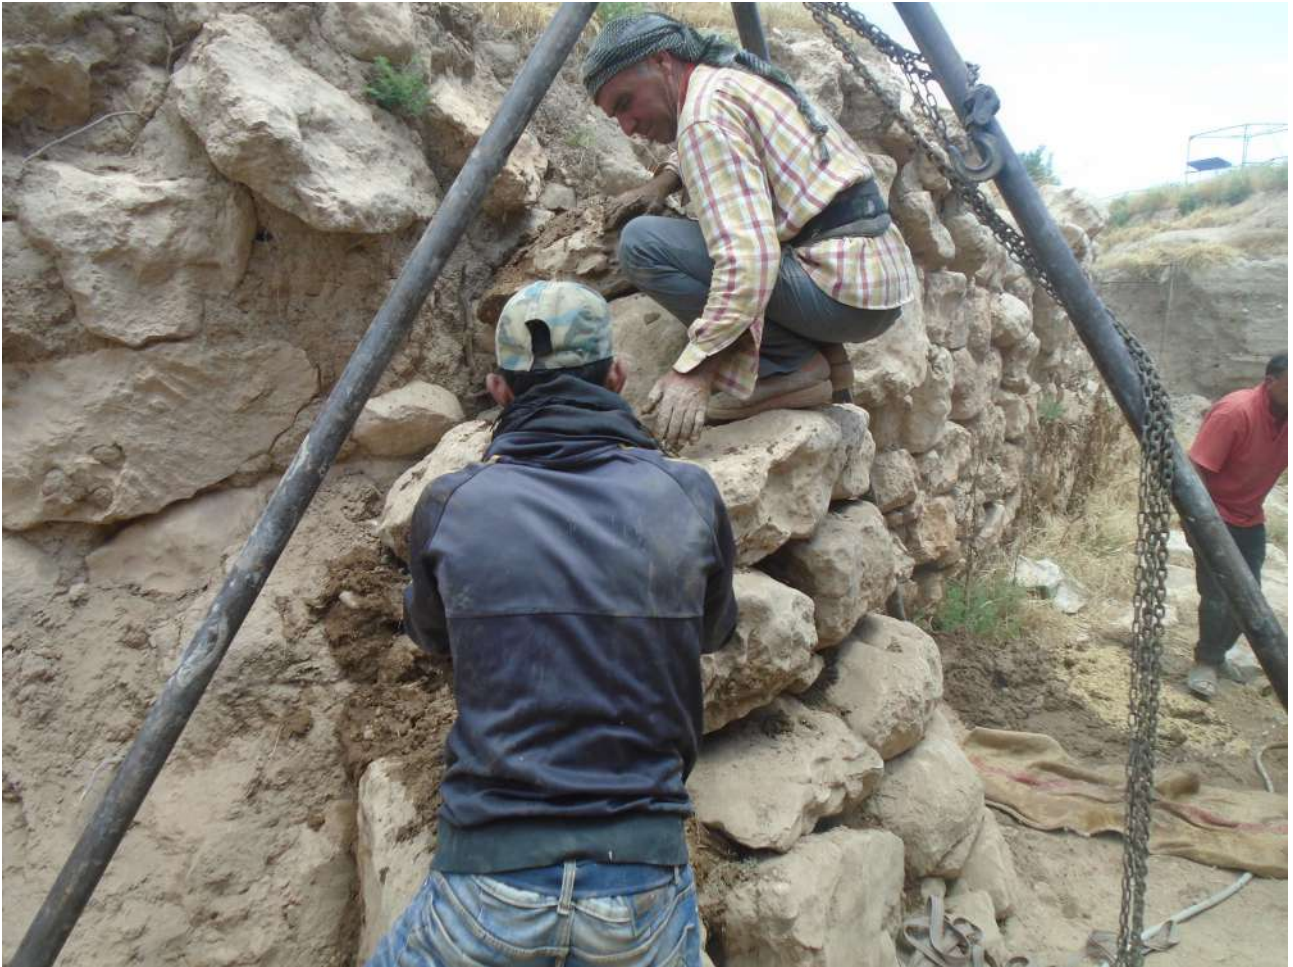
Fig.8 . Filling the gaps between the stones with mud - the unit J5

The stones have been lifted by al-Wensh, so was the mud (a mixture of soil, straw and water) , in order to cover the gaps between the stones ( **Fig.8** ).

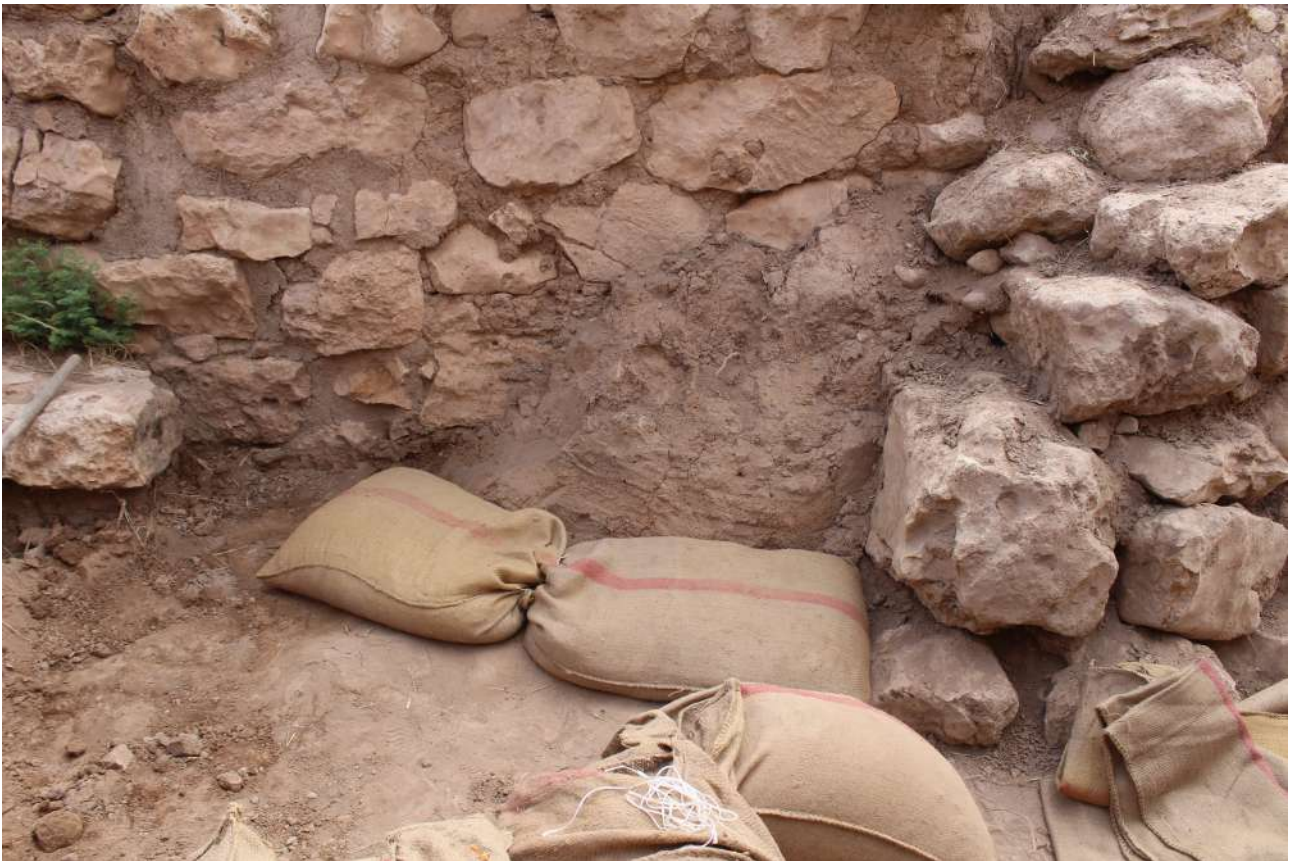
Fig.9 . Burlap bags filled with soil - the unit J5

In respect of the unit J5, after we finished putting the stones we had to strengthen the wall of the temple as well as we can, and cover the remaining soil which was stuck on the wall of the temple, in addition to giving the new buttress a kind of aesthetic appeal until it can be restored properly, so we used filled burlap bags with Soil ( **Fig.9** ), these bags were filled from the collapsed soil from the original buttress itself, which was spread on the ground . The bags have been carefully placed until we reached the highest point possible ( **Fig.10** ), but we have stopped work in this unit because we ran out of the soil which was collapsed of the buttress .

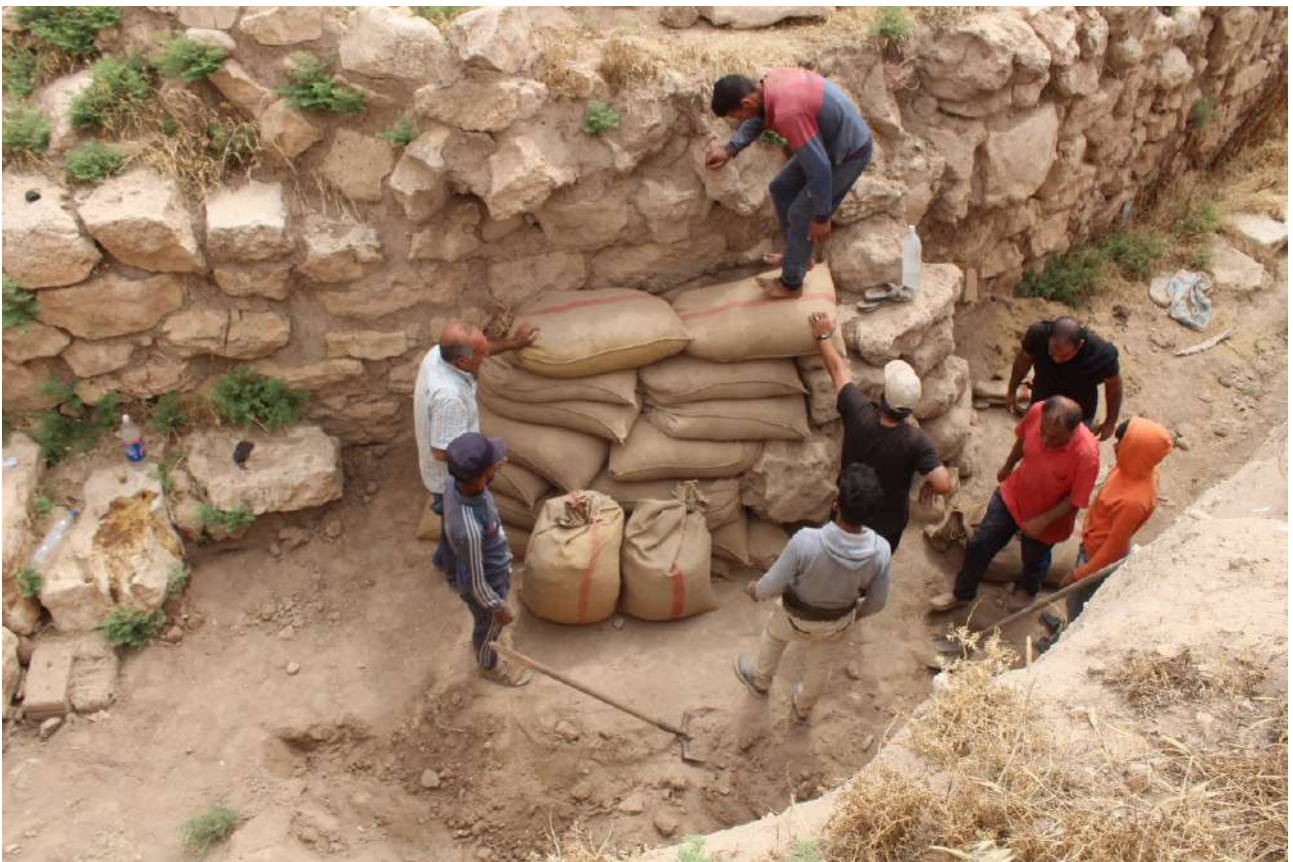
Fig. 10 . The highest point we reached on third day - the unit J5

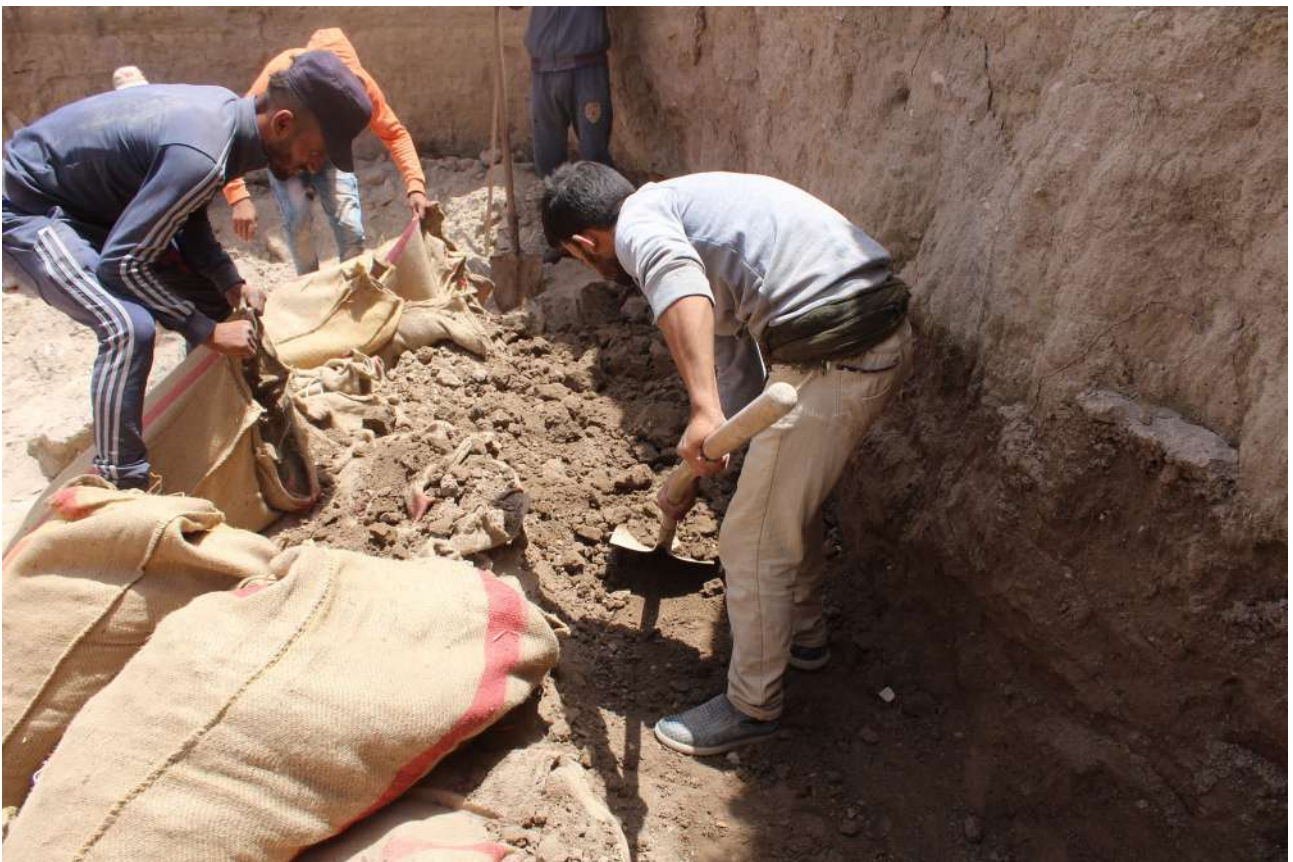
Fig.11 . The work began in the unit J1

As for the unit J1, we began to remove the soil beside the wall of the section from both south and east sides ( **Fig.11**), in order to reach the position where we can put the bags and to be sure that the wall of the section will be protected, the extracted soil was directly being filled in the bags ( **Fig.12** ) .

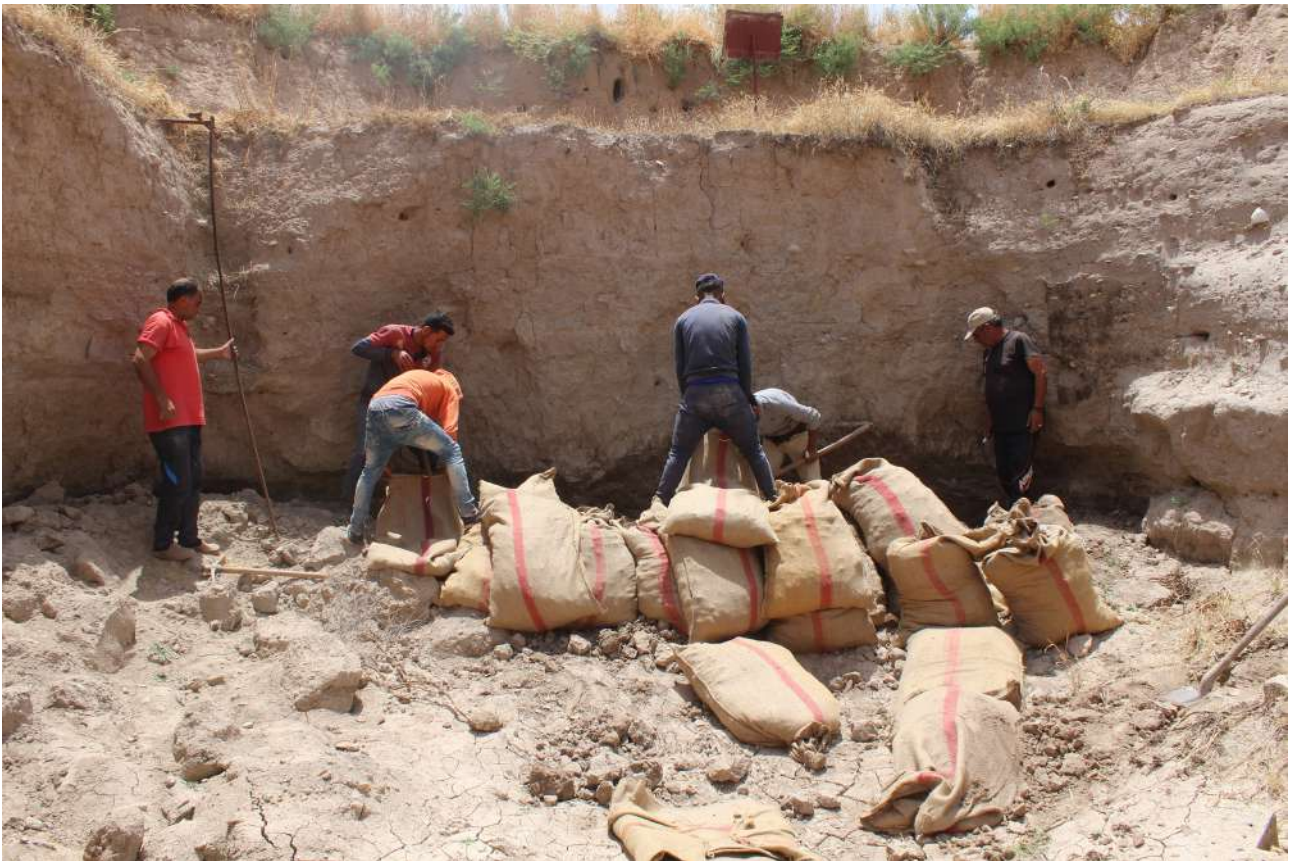
Fig.12 . Filling the bags - the unit J1

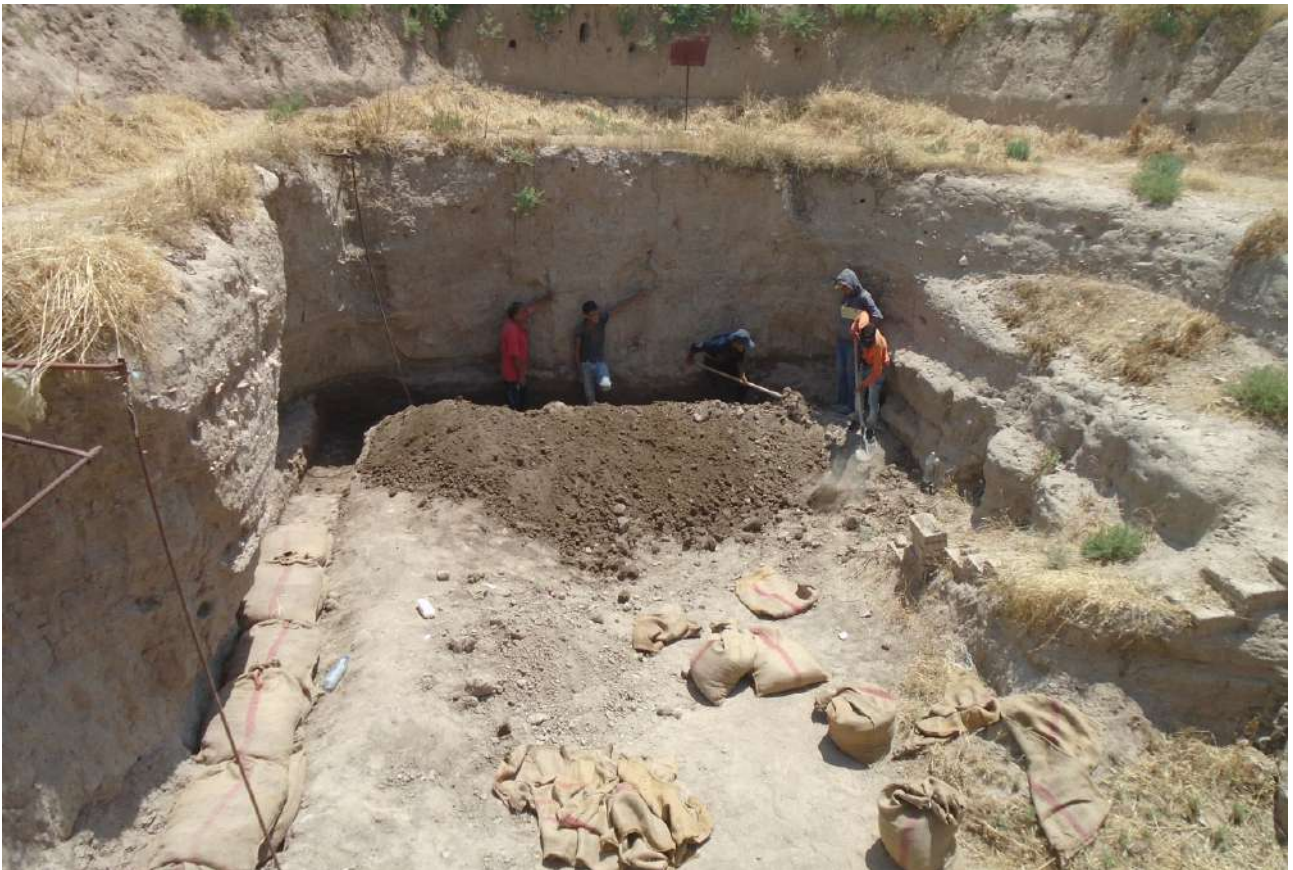
Fig.13 . The work is continued in the unit J1

The process of removing soil beside the east and south sides of the section in the unit J1 continued, as well as placing the bags in the eastern side ( **Fig.13** ). In respect of the soil which will be used for the protection of the temple's wall, we preferred to sift it to make sure that it doesn't contain shards or other objects ( **Fig.14** ), Hammadi was interested in collecting every fragment that appeared as a result of the sifting process ( **Fig.15** ), we didn't see any fragments except for some pottery shards which were placed in plastic bags by Hammadi himself ( **Fig.16** ). The sifted soil was filled in the bags and transferred to the top , in order to use them later in the protecting the temple's wall ( **Fig.17** ) .

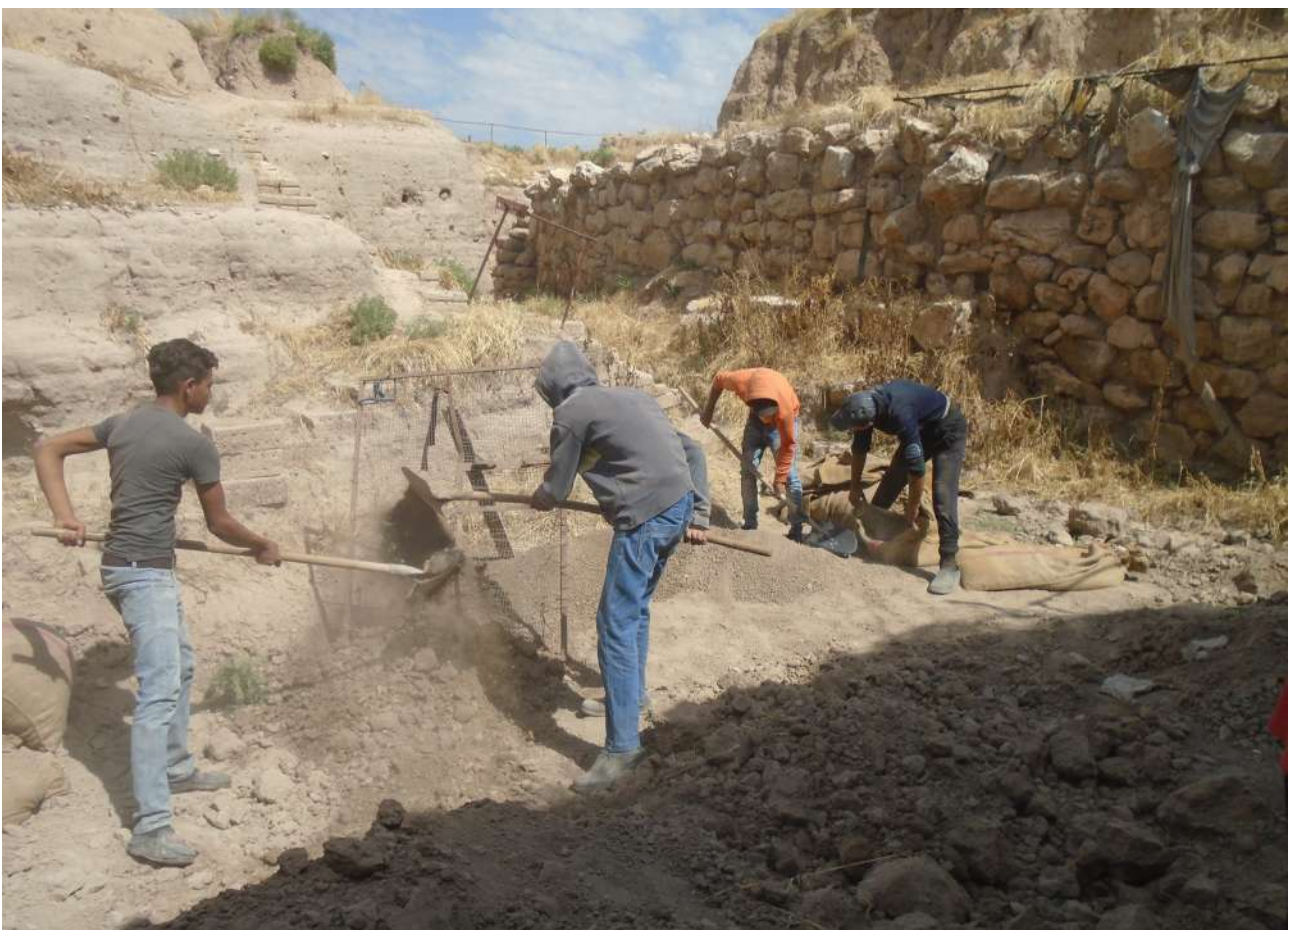
Fig.14 . Sifting the soil - the unit J1

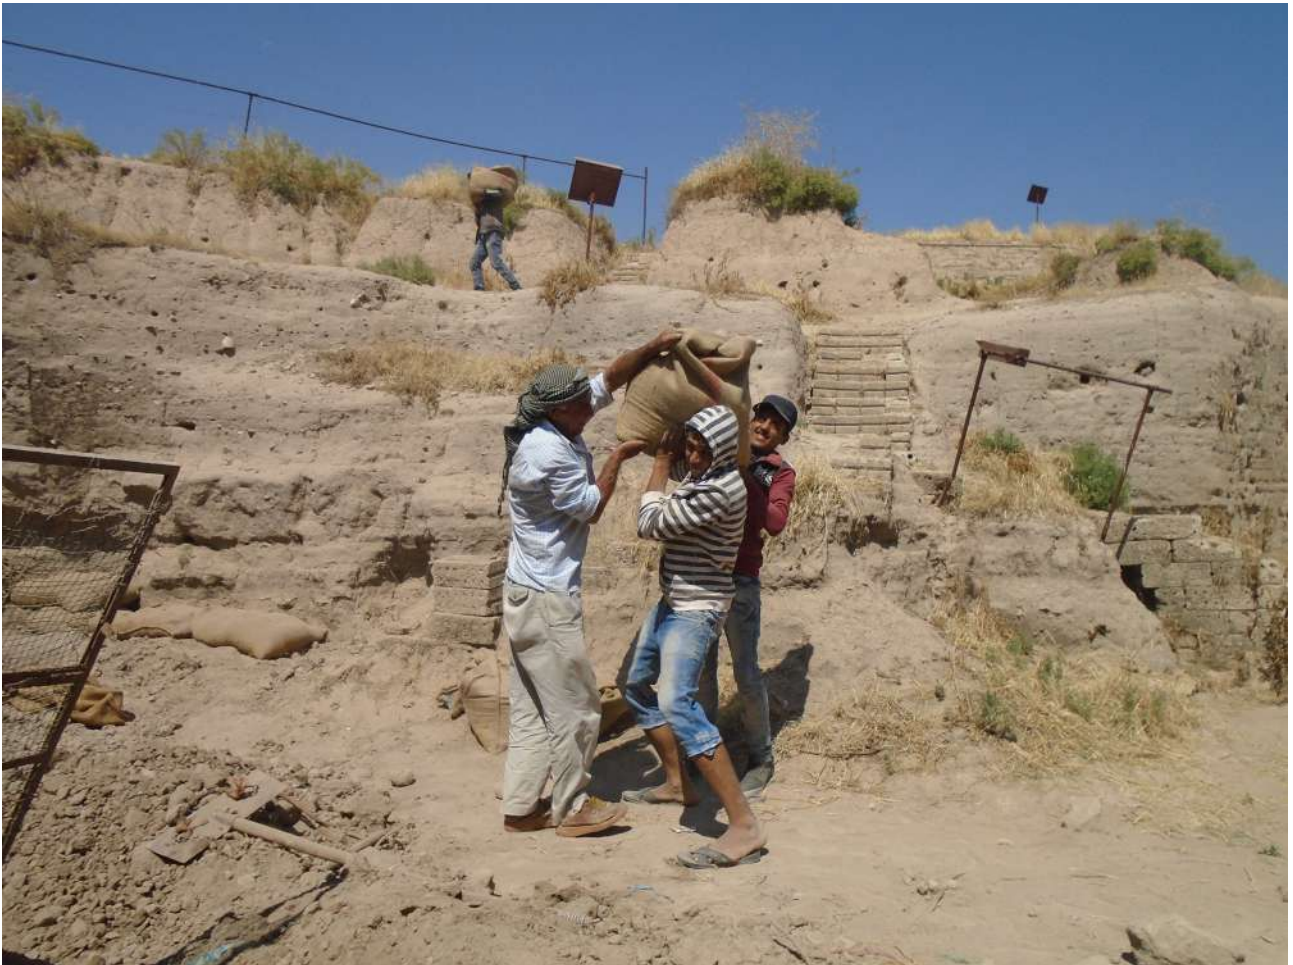
Fig.17 . Transferring the soil bags to the top - the unit J1

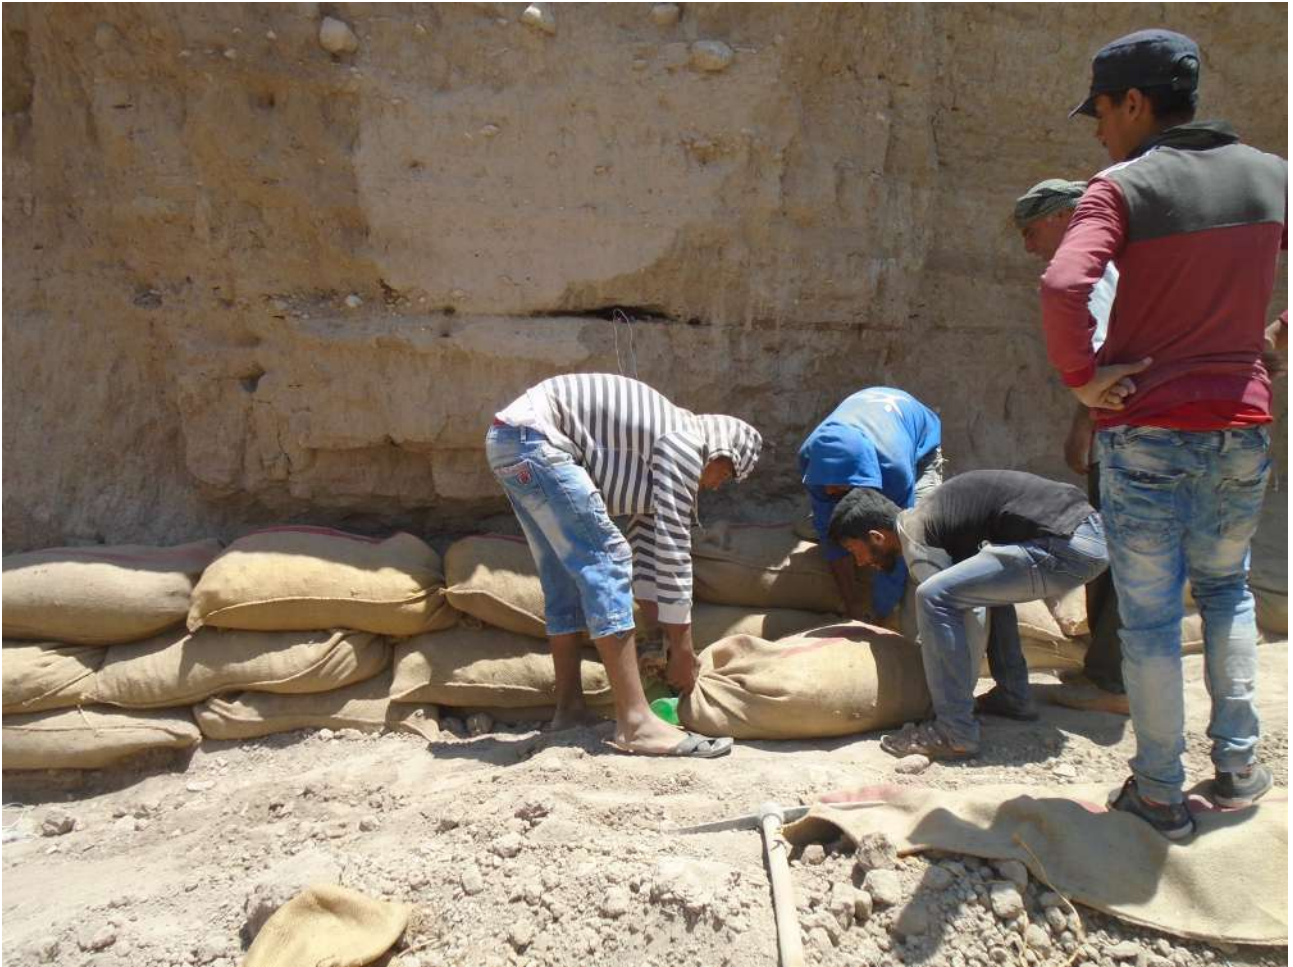
Fig.18 . Placing the soil bags - the unit J1

In the unit J1, we continued filling bags with soil and placing them in both sides, the eastern and southern sides of the section ( **Fig.18** ), in addition to sifting the soil and transferring it .

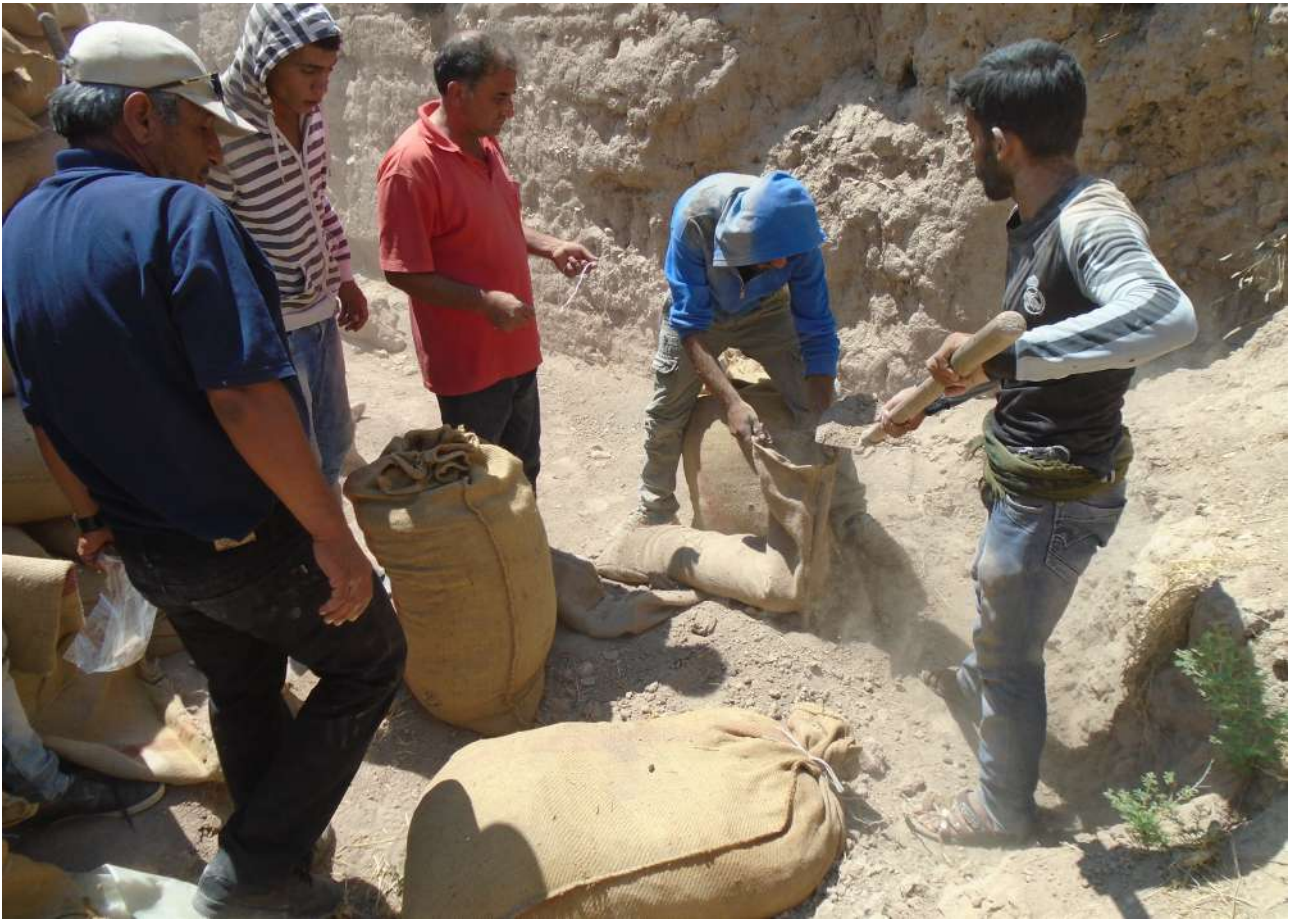
Fig.19 . Removing soil from the collapsed section in front of the buttress

As for the unit J5, after we ran out of the soil which collapsed from the original buttress, we had to use the soil which also had previously collapsed from the section in front of the buttress ( **Fig.19** ), the bags which have been filled from the section's crumbled soil, I named them as (from section), the photo which I have drawn by Freehand Program will illustrate them ( **Fig.20** ), then we continued placing one bag on top of the other, until the work in this unit was entirely finished ( **Fig.21** ) .

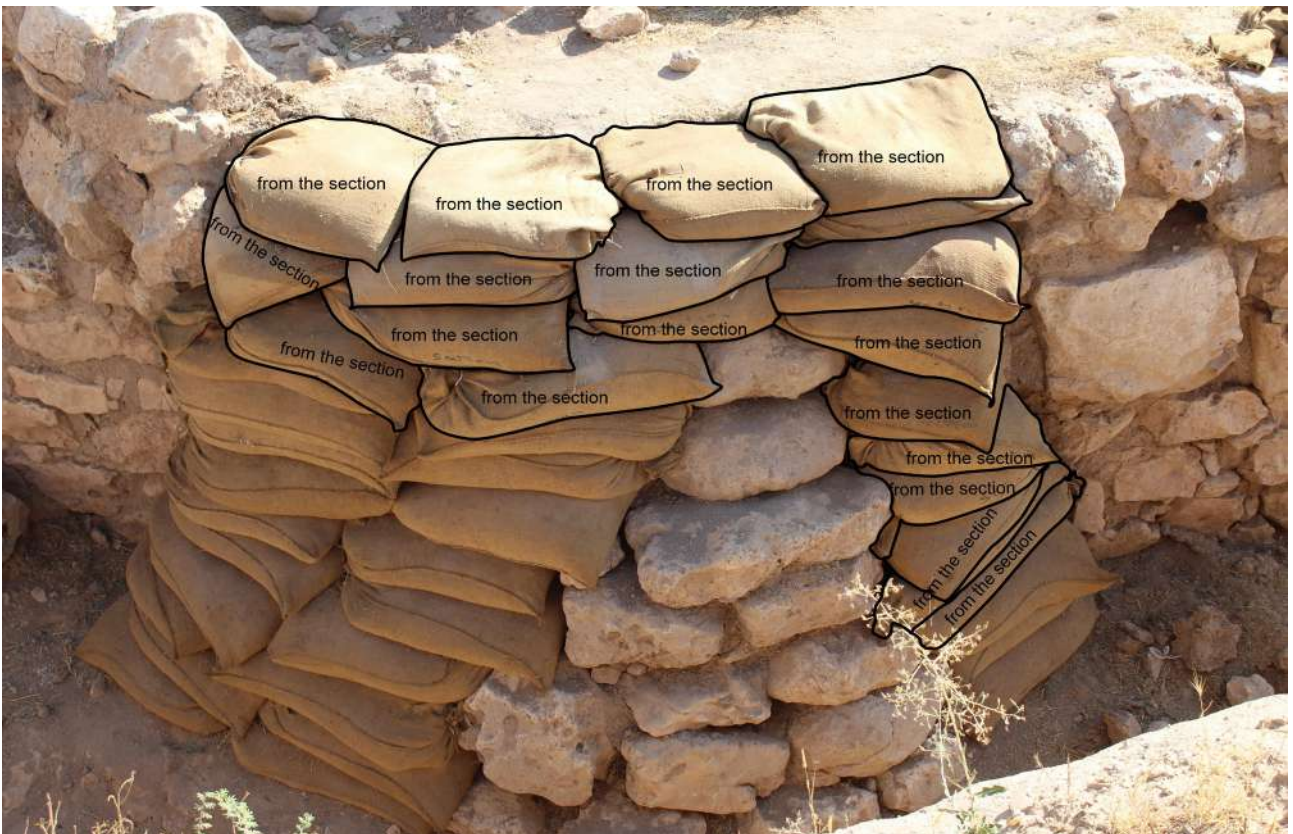
Fig.20 . Photo illustrating the bags which have been filled from the collapsed section
