## The maintenance works in the area J1

Amer Ahmed

Date : 11 / 9 / 2019

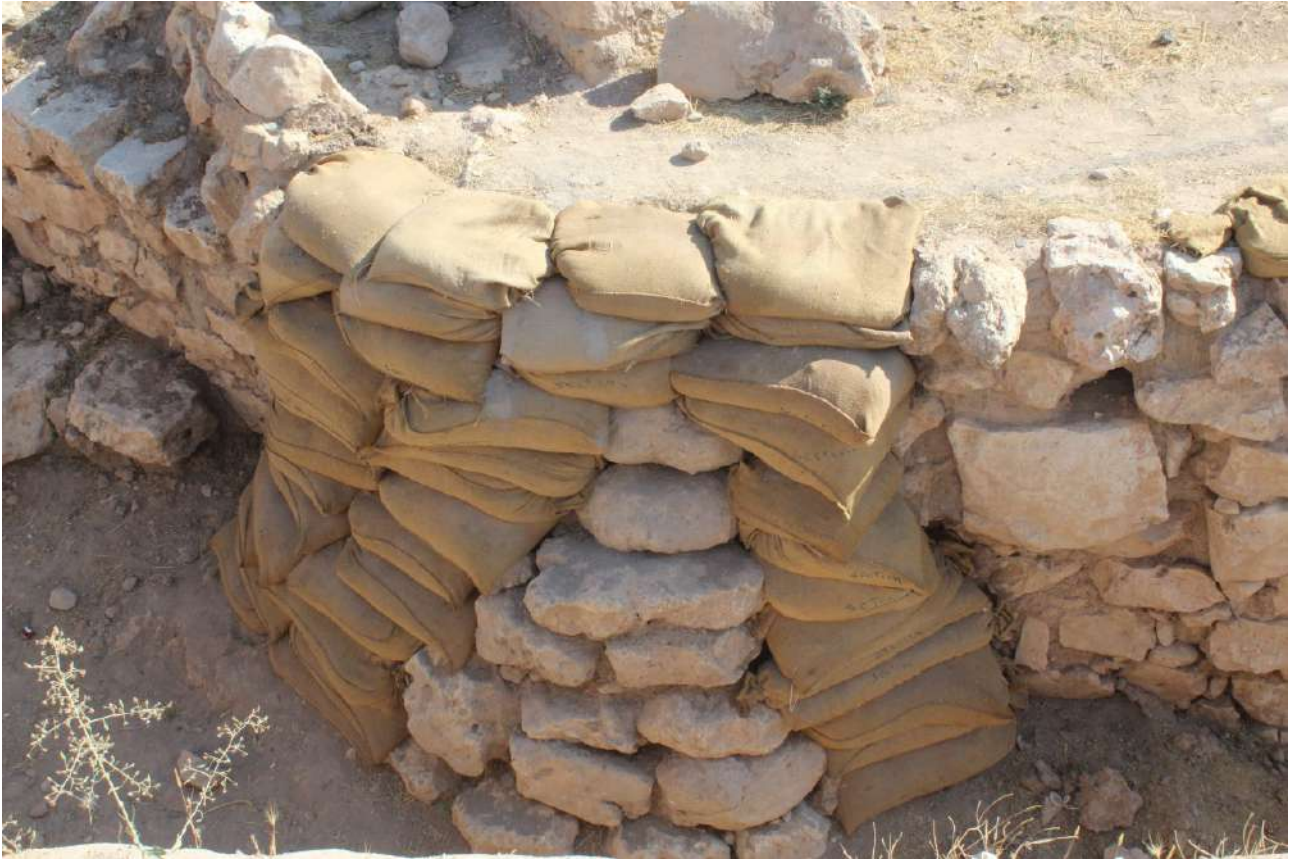
Fig.21 . The new buttress - the unit J5

As for the unit J5, after we ran out of the soil which collapsed from the original buttress, we had to use the soil which also had previously collapsed from the section in front of the buttress ( **Fig.19** ), the bags which have been filled from the section's crumbled soil, I named them as (from section), the photo which I have drawn by Freehand Program will illustrate them ( **Fig.20** ), then we continued placing one bag on top of the other, until the work in this unit was entirely finished ( **Fig.21** ) .

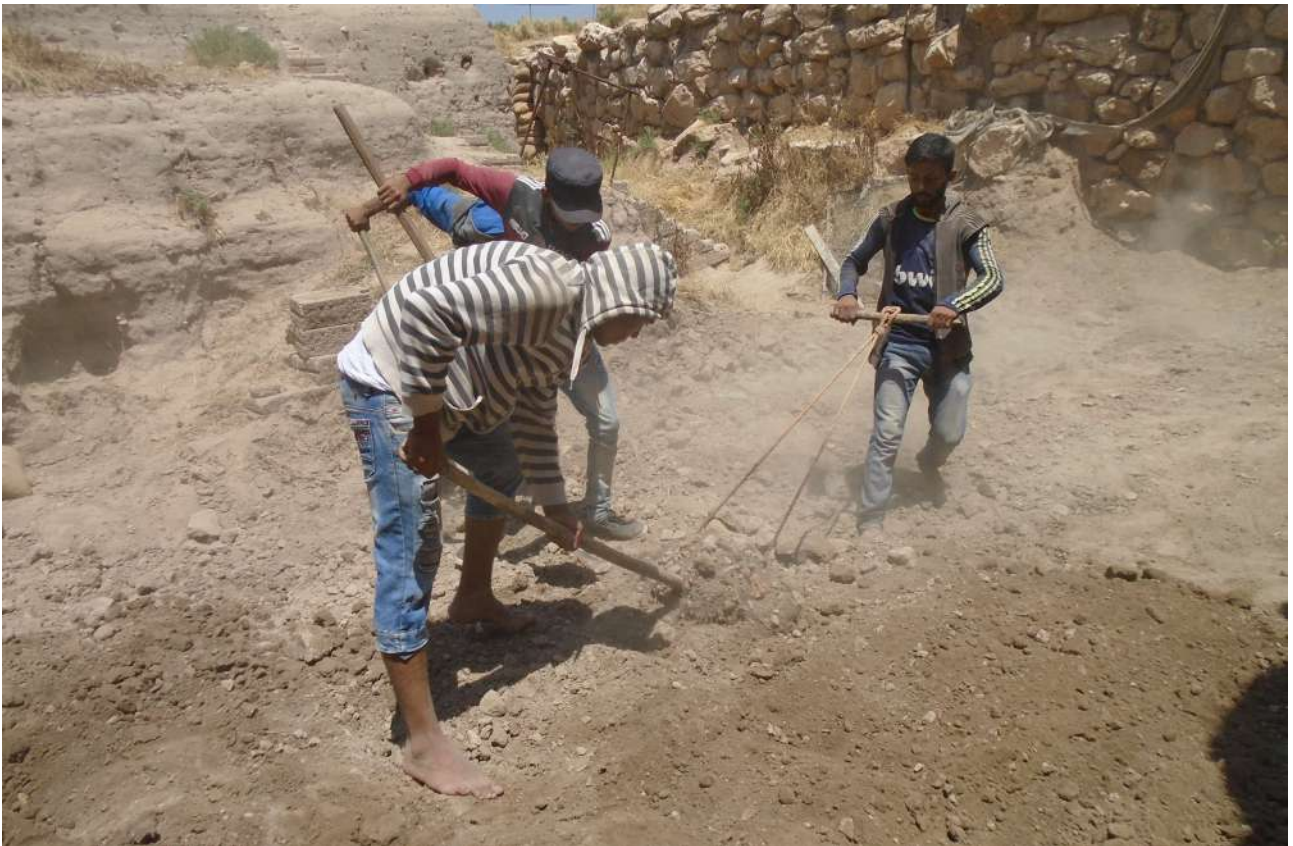
Fig.22 . The process of leveling the soil in the unit J1

We finished the work in the unit J1 , where the bags have been placed and the soil settled within the unit ( **Fig.22 and 23** ) .

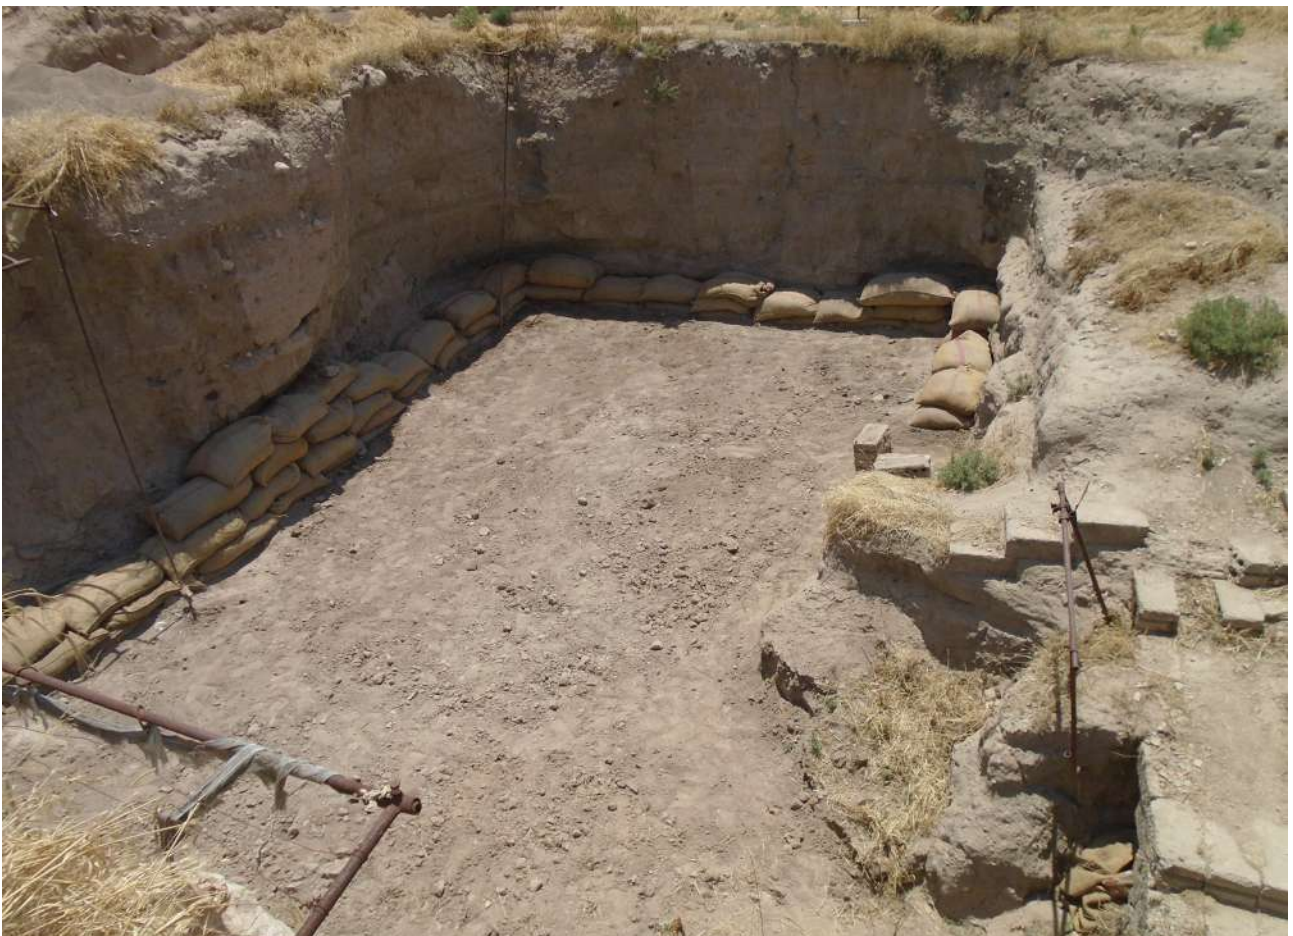
Fig.23 . View of the end result in the unit J1

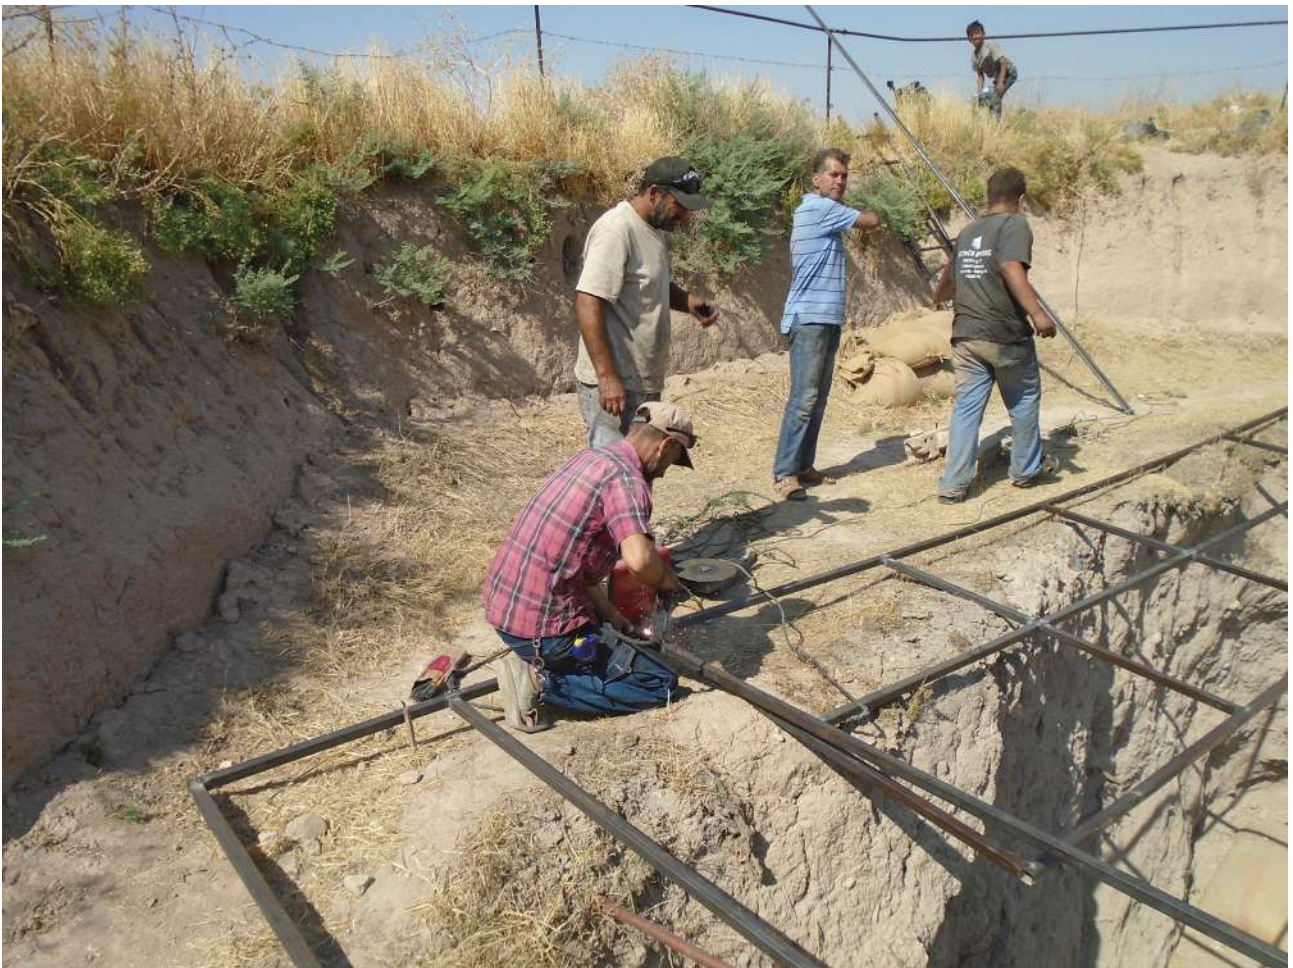
**Fig.24 . installing the iron rods - the unit J1**

After we have finished the work inside the unit J1, we moved to the second phase which is installing iron rods ( **Fig.24** ) and covering them by metal sheet which is called in the local language as tutia ( **Fig.25** ), where it was well fixed on the iron rods , in order to protect the section's wall from the rain in the next winter seasons . we also welded the broken western door leading to the unit J1 ( **Fig.26** ) . thus we finished our work in the unit J1 ( **Fig.27** ) .

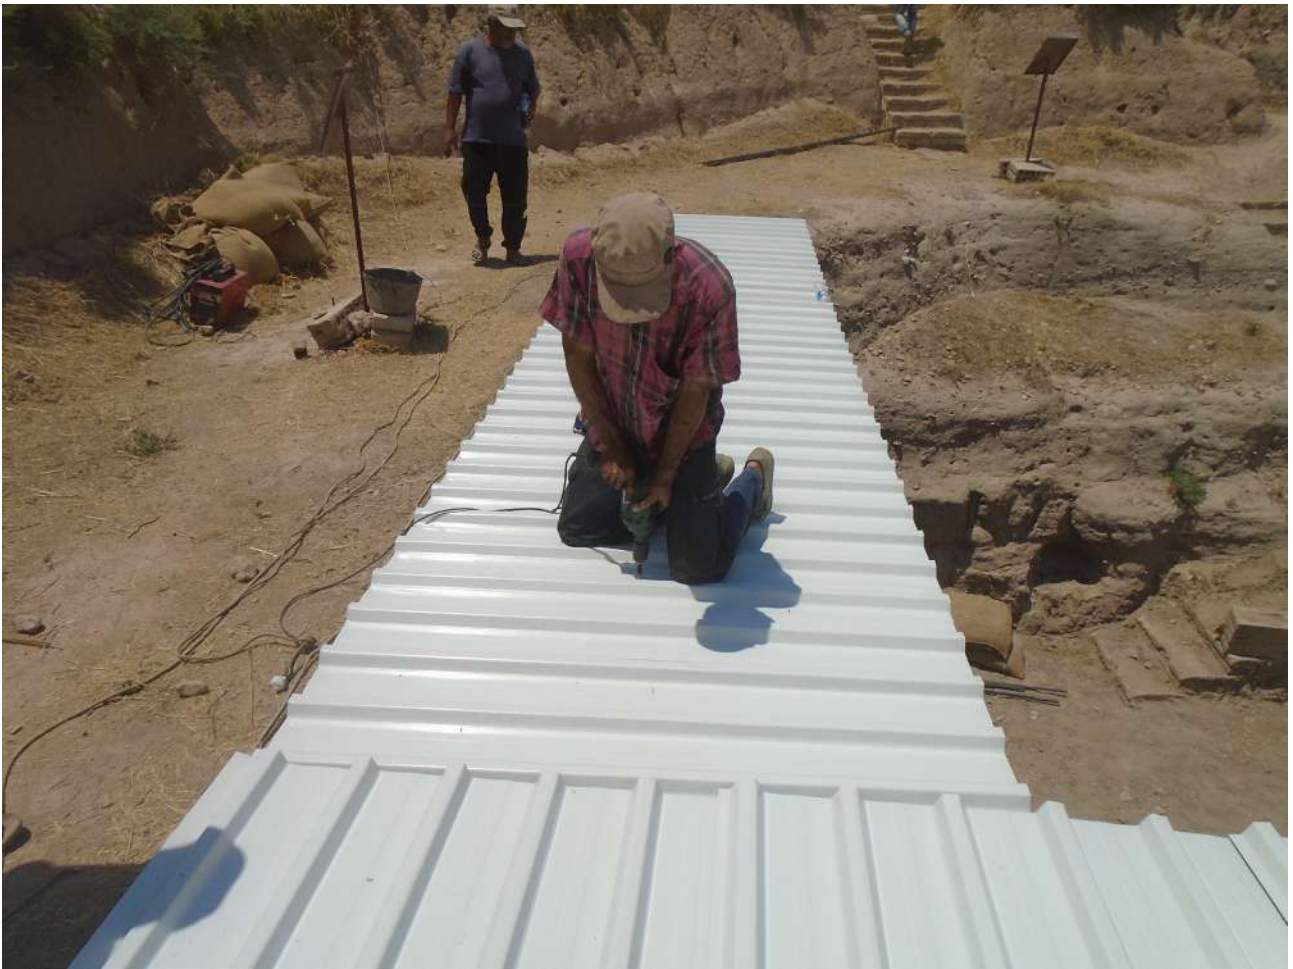
Fig.25 . Fixing the tutia with the iron rods - the unit J1

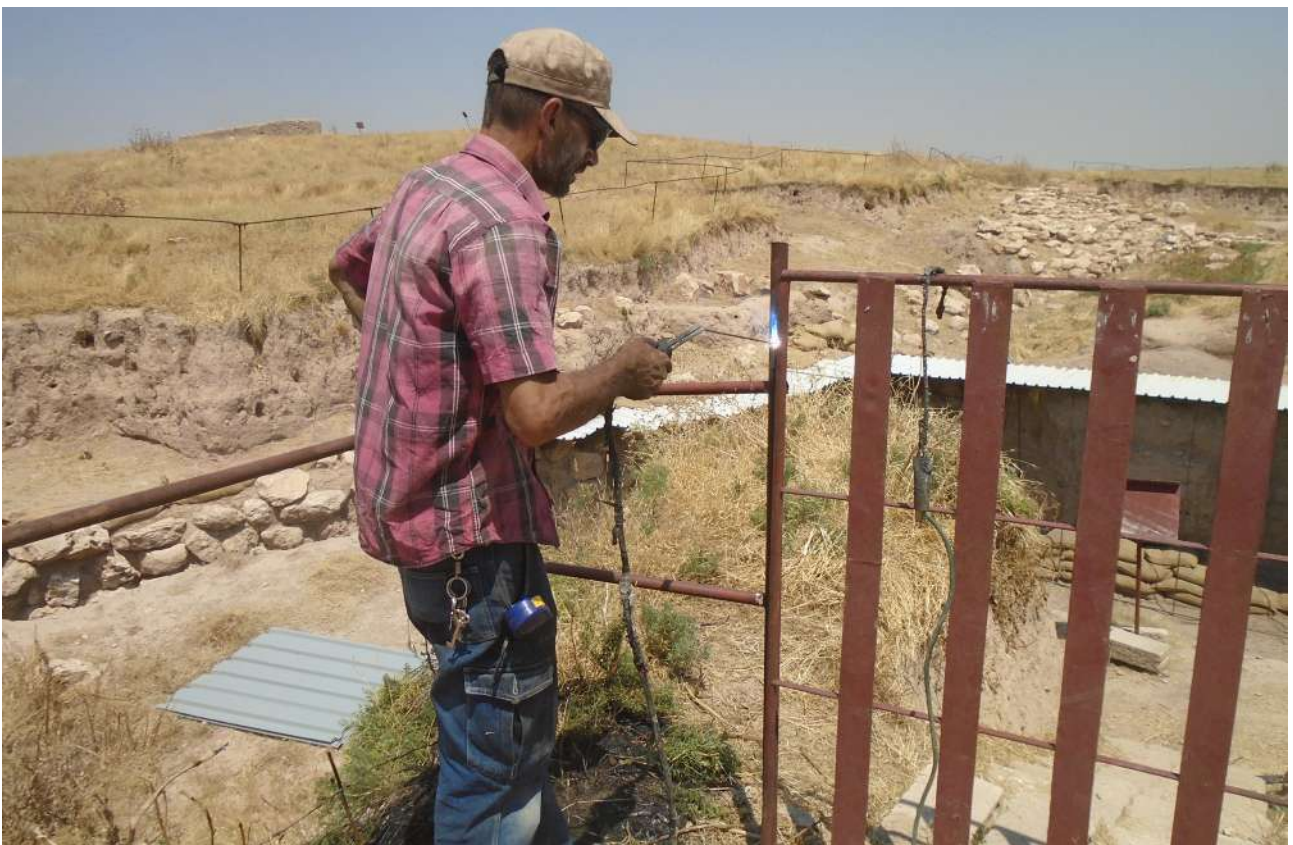
Fig.26 . Welding the iron door in the unit J1

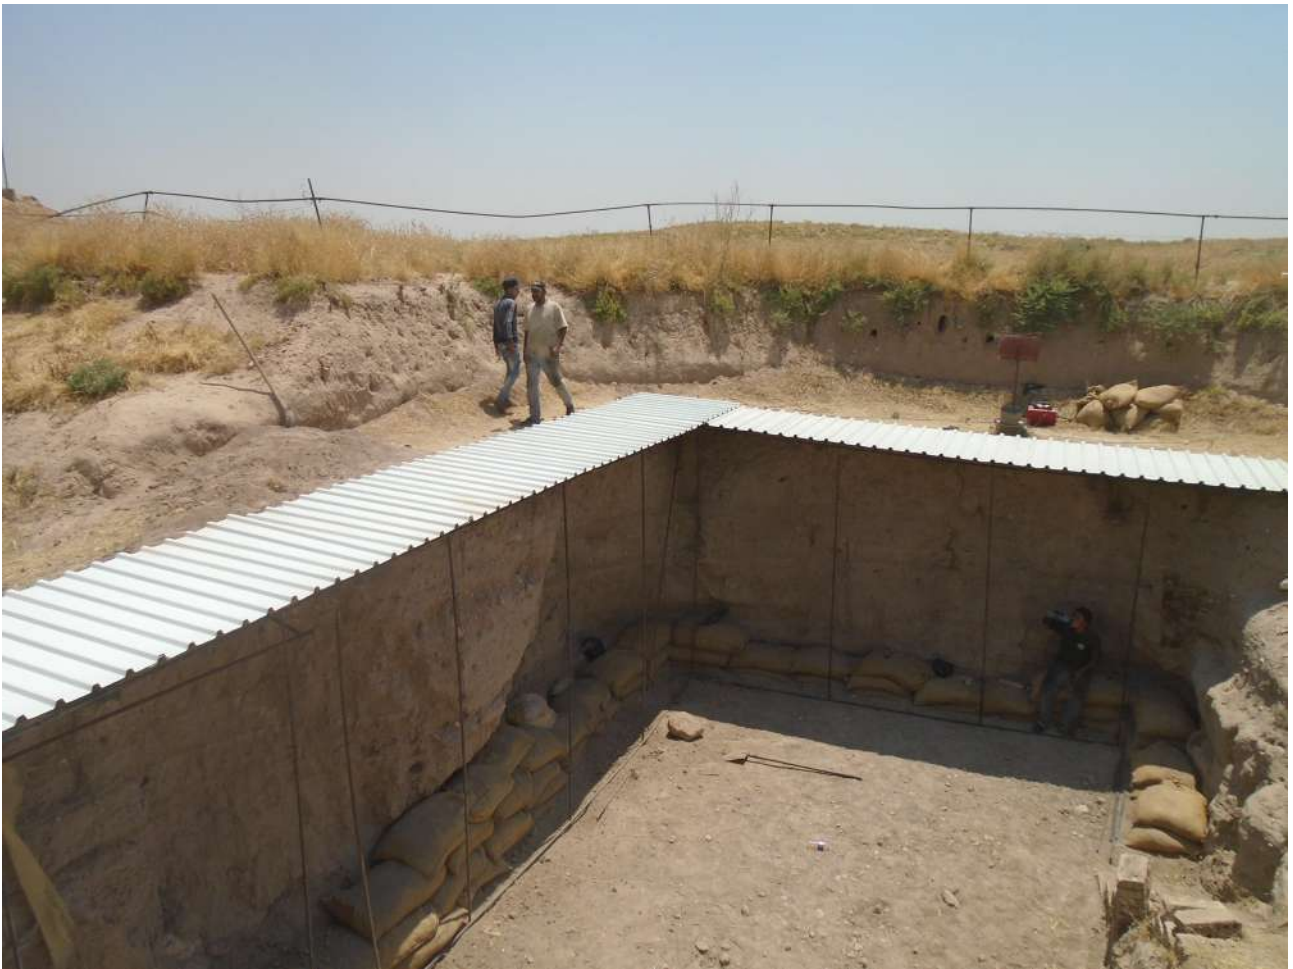
Fig.27 . Iron rods and tutia secured in place, in the unit J1

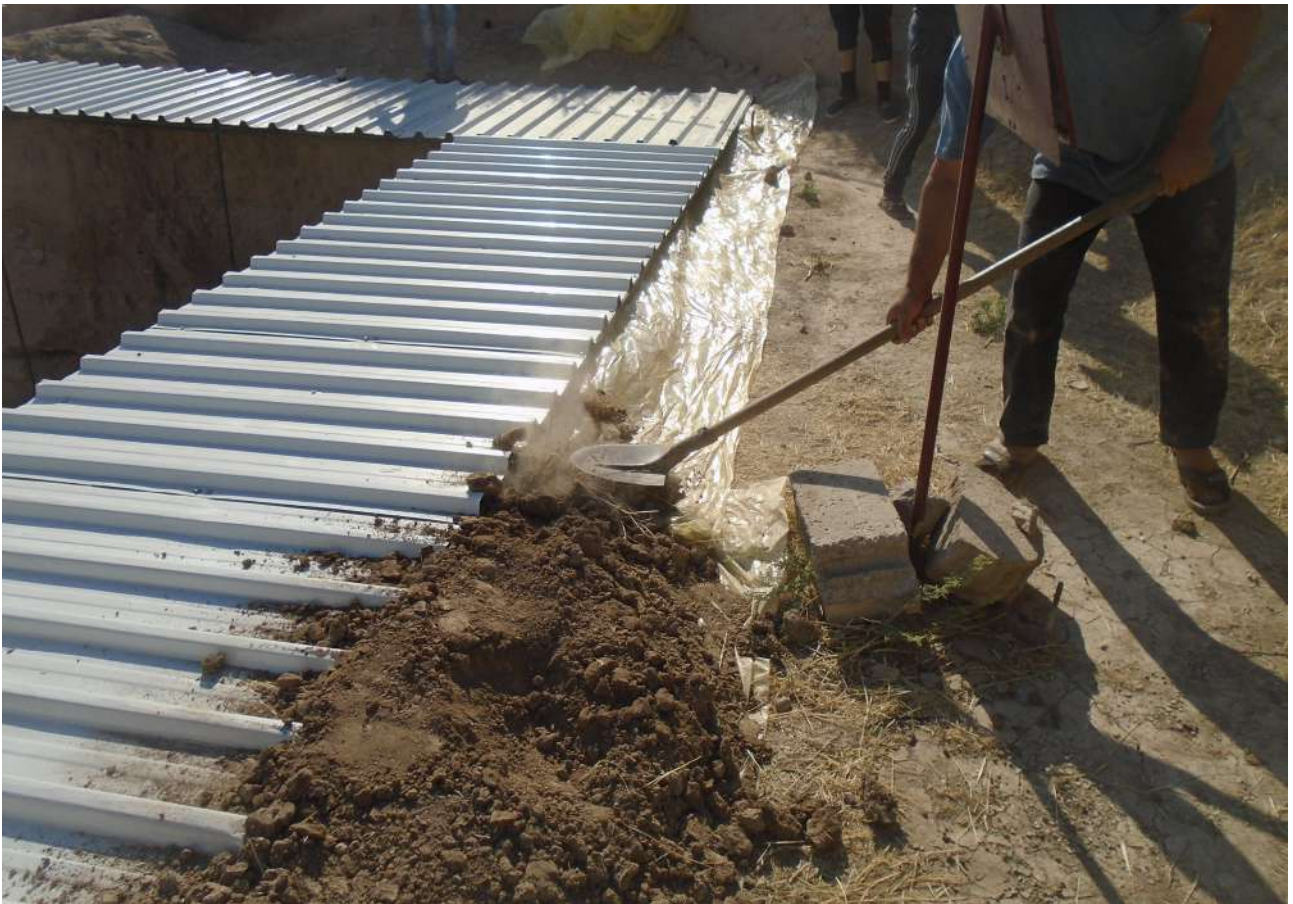
Fig.28 . Covering the edges of tutia with soil - the unit J1

After installing the iron rods and tutia, we covered the edges of the tutia from the top by soils ( **Fig.28** ), to prevent any leaking of rain water that may cause damages to the section in the unit J1. Then we moved to placing tutia on the surface of the temple's wall. Here we faced obstacles, as the prominent stones in the surface of the fence starting from the unit J1 through the unit J5, which made our work so difficult, preventing us from controlling the settlement of tutia because of the stones, where the sheets of tutia were being tilted ( **Fig.29** ), and we would have needed a large amount of soil to level it , however and after many attempts we became sure that this way will be useless , so after careful consulting we decided to use burlap ( Jader ) to cover all the wall from top to bottom and fixing it by bags of soil ( **Fig.30** ) , which will be placed at the end of autumn and removed around the middle of March .

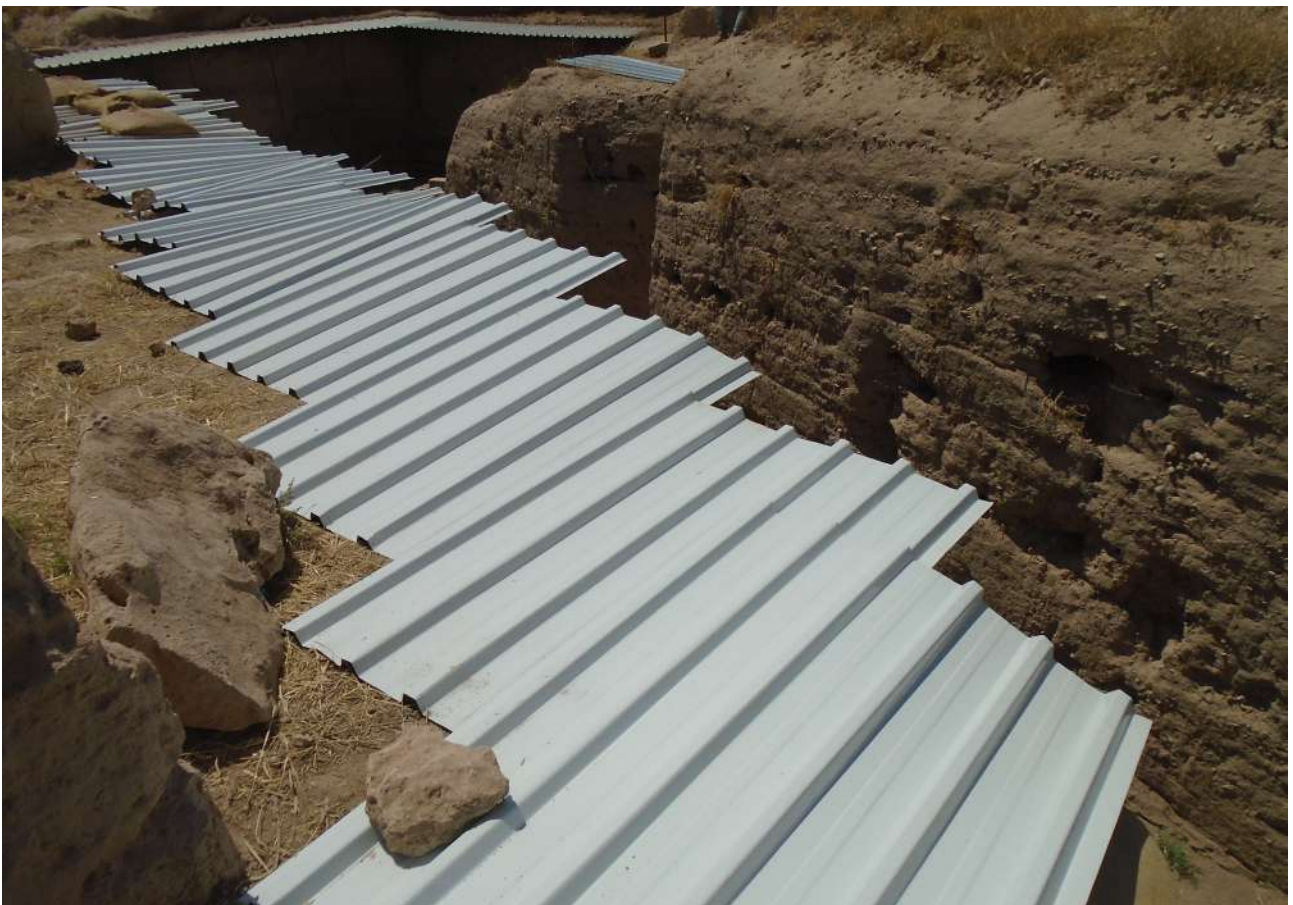
Fig.29 . The sheets of tutia are waving because of stones - the wall of temple

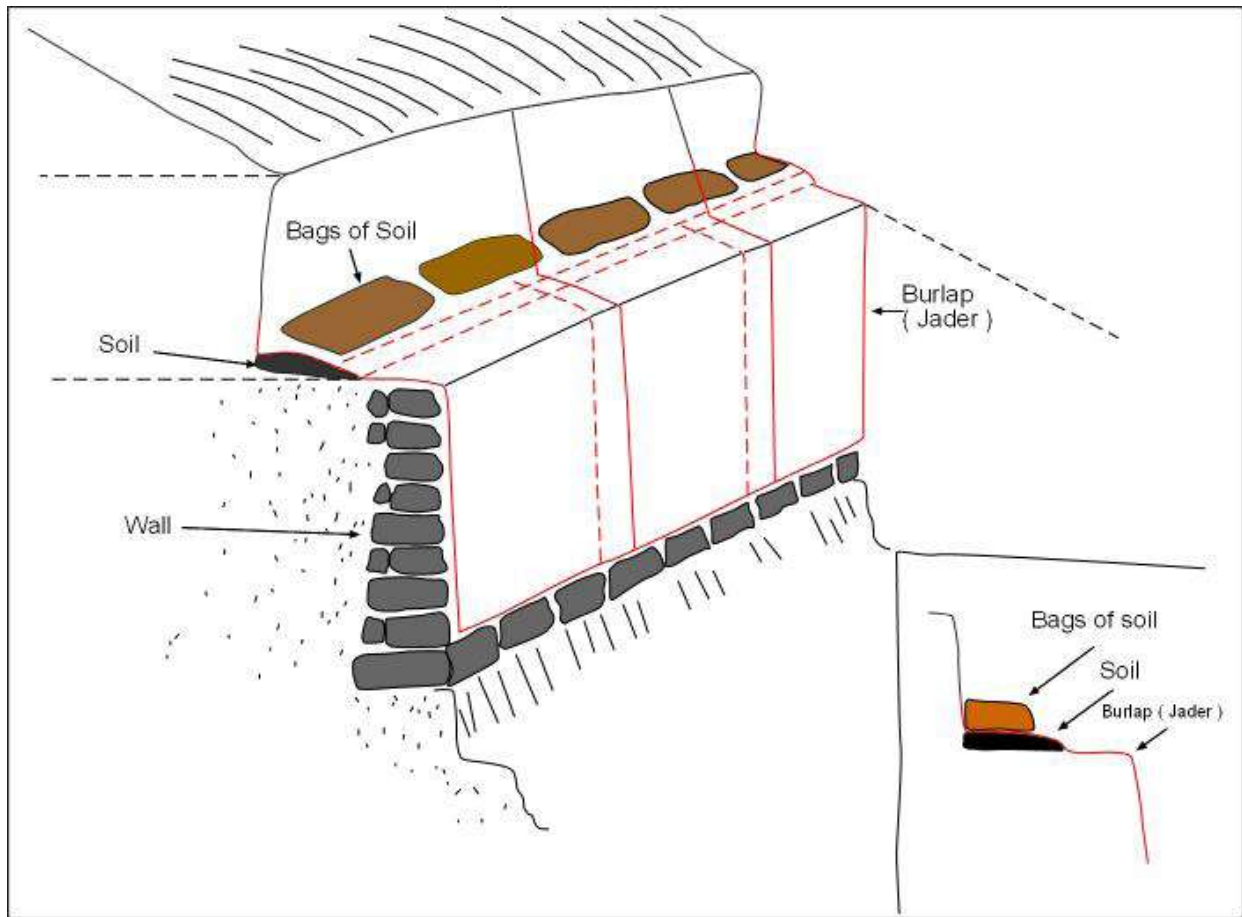
Fig.30 . The suggestion process for the temple's wall

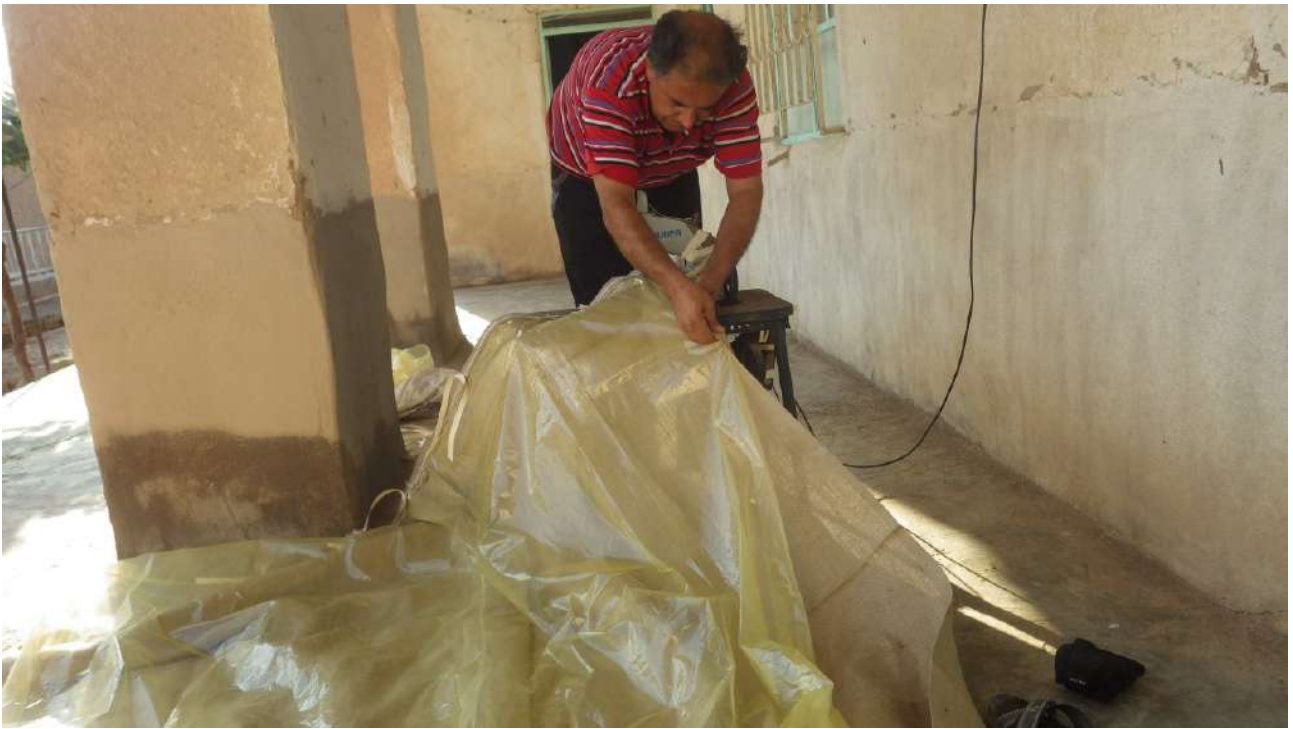
Fig.31 . Sewing the burlap with plastic ( Nylon )

After finishing work in the unit J1, where the iron rods and tutia have been installed, we fixed burlap curtain which have been sewed with plastic ( Nylon ) ( **Fig.31** ) and fixed by ribbons on the iron rods ( **Fig.32** ), the plastic was very necessary in order to avoid the the effect of moisture on the section . The metal rods were close to each other, about 180 cm apart, except in the corners of the unit ( northeast and southwest corners ), the side of the Nylon was installed against the wall of the section .

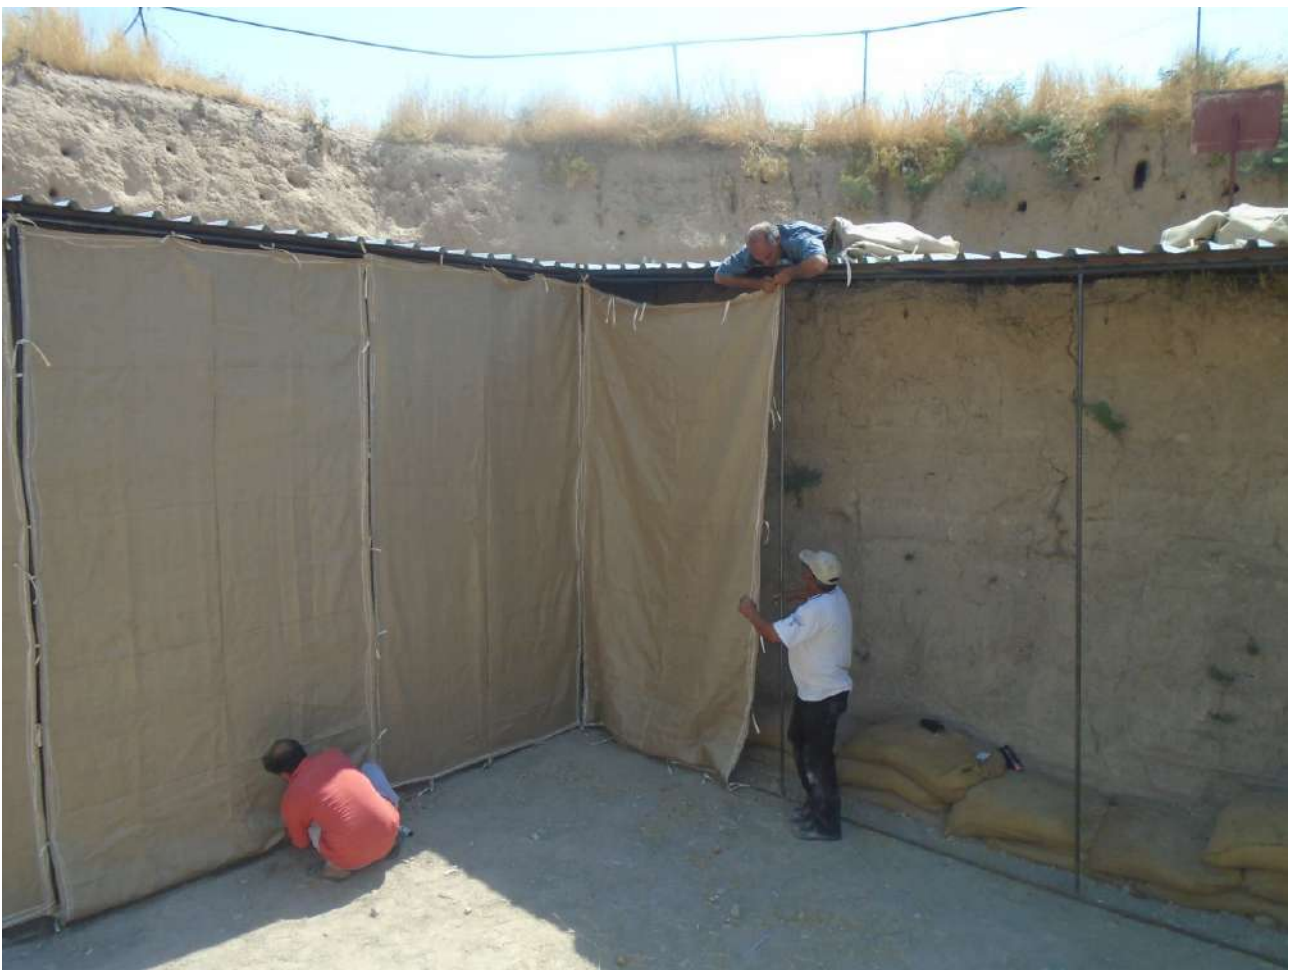
Fig.32 . Fixing the curtain on iron rods by ribbons - the unit J1

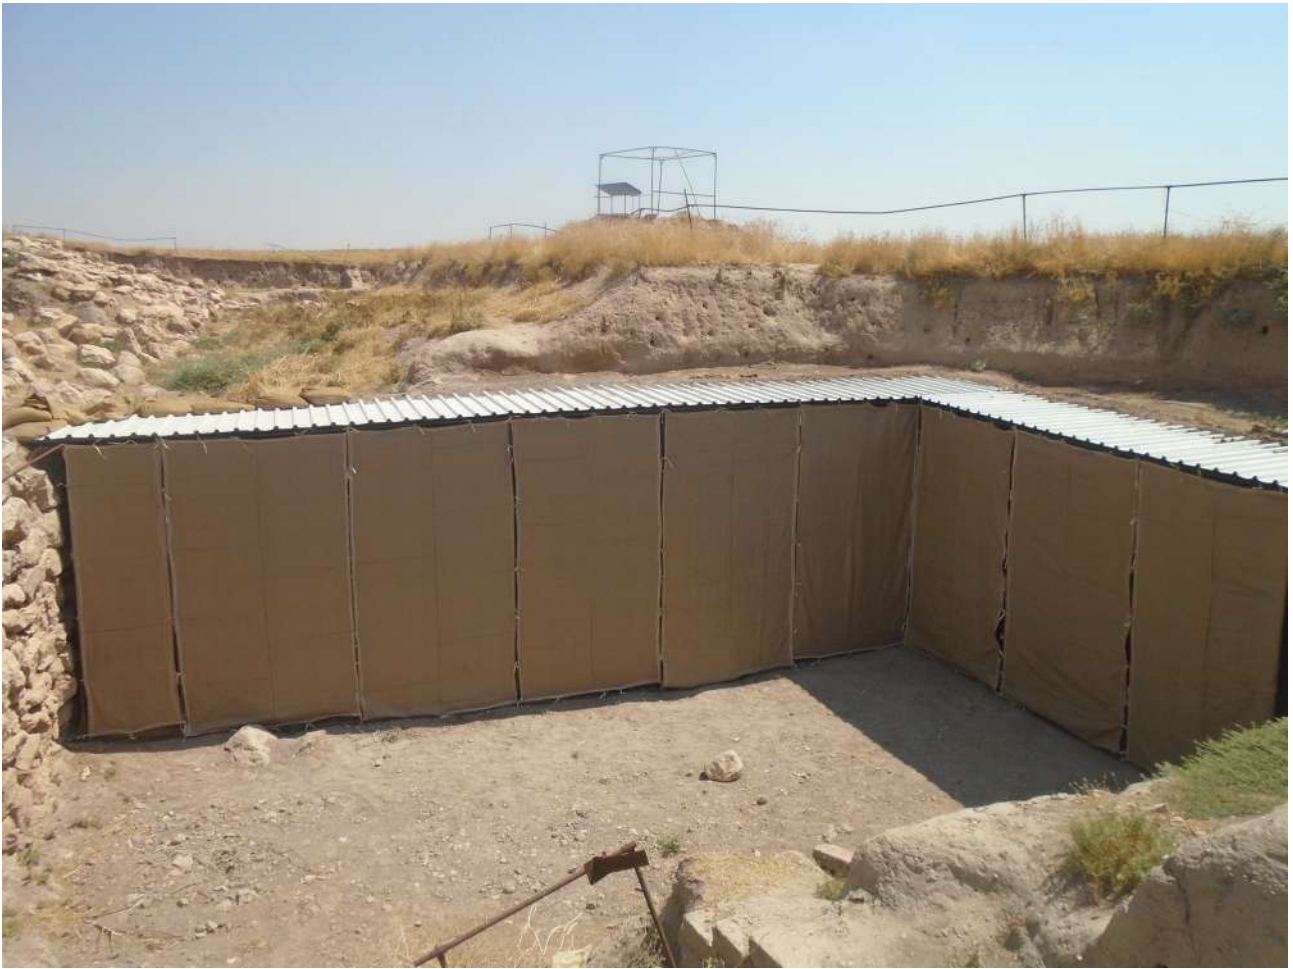
Fig.33 . The unit J1 from the northwest side

The unit J1 after finishing work on the ninth day ( **Fig.33** ).

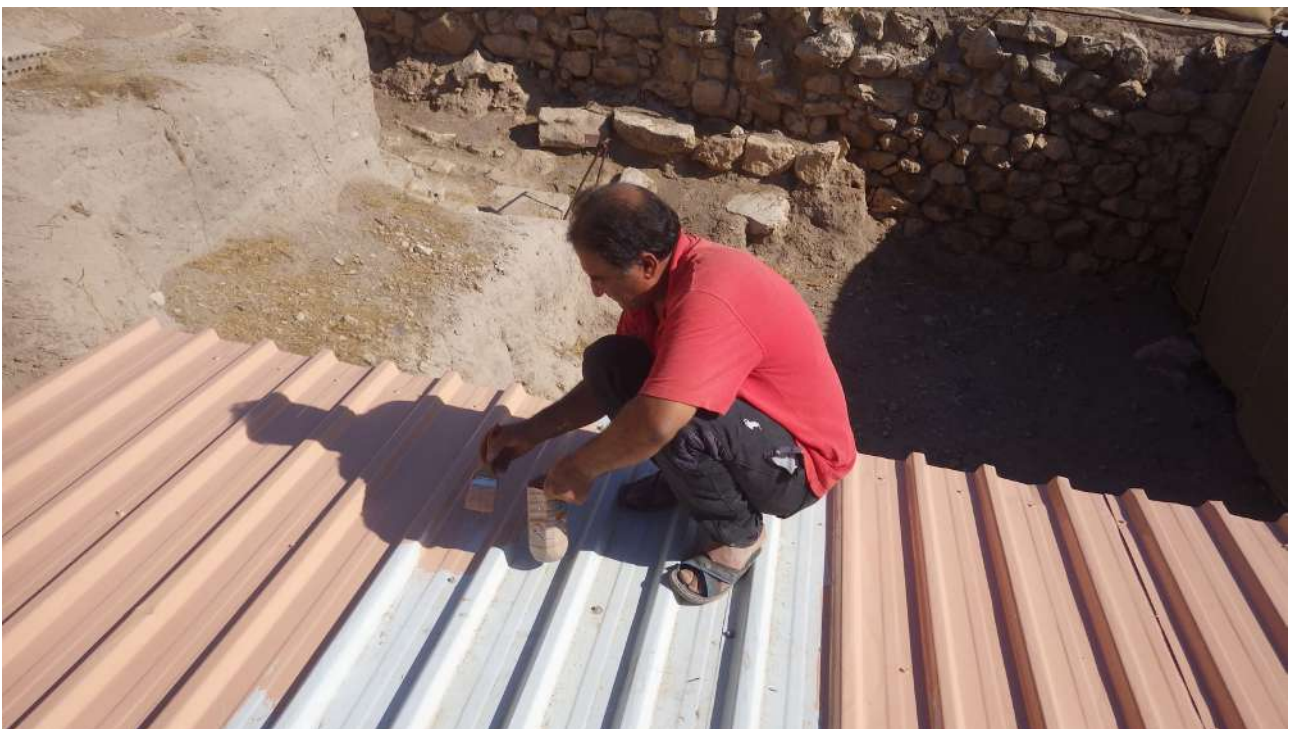
Fig.35 . The painting process

We painted the tutia in the unit J1, where we have mixed three colors, light brown, white and orange ( **Fig. 34** ), in order to be as close as possible to earthy color ( **Fig.35 and 36** ) .

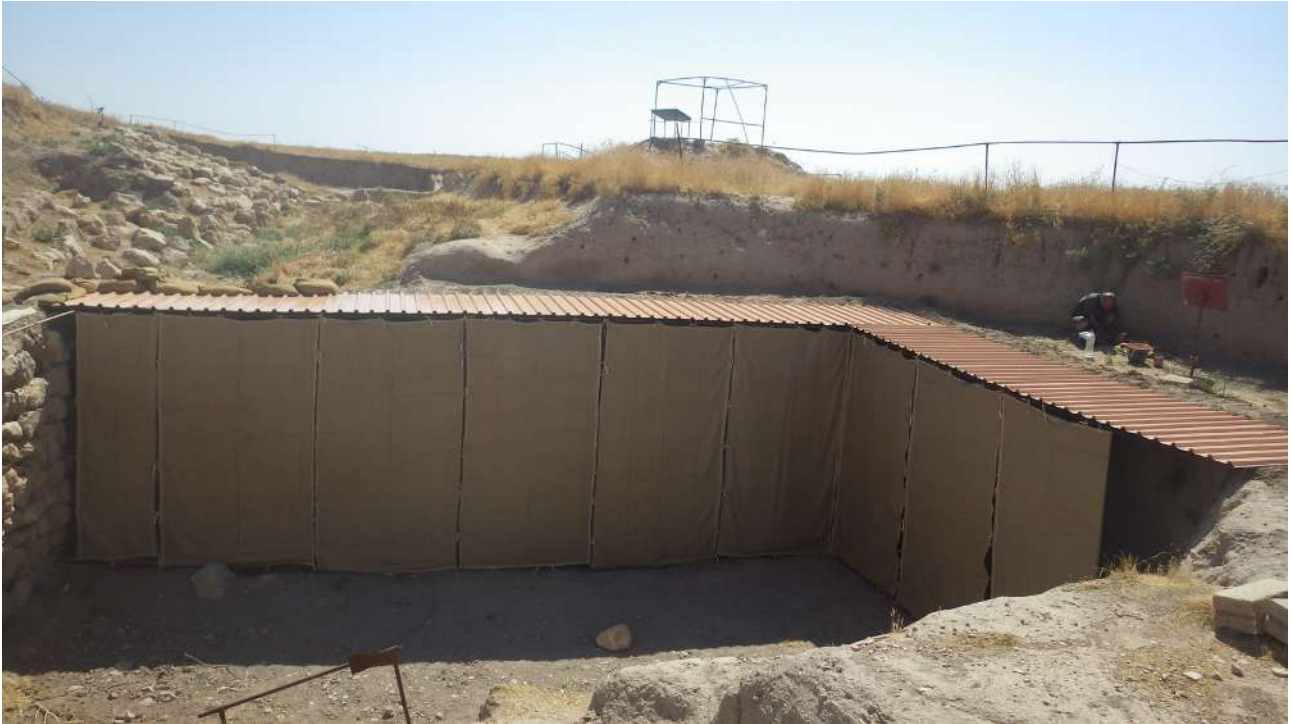
Fig.36 . The unit J1 after painting process
